**UPDATED SUMMARY REPORT ON THE LA REFORMA PROPERTY  
(Detailing the Results of Recent Exploration and Diamond Drilling)**

**Sinaloa State, Mexico**

**VICTORY RESOURCES CORPORATION  
13236 Cliffstone Court  
Lake Country, BC V4V 2R1**

**Ruben S. Verzosa, P.Eng.  
23064 – 50<sup>th</sup> Avenue  
Langley, B.C. V2Z 2R7**

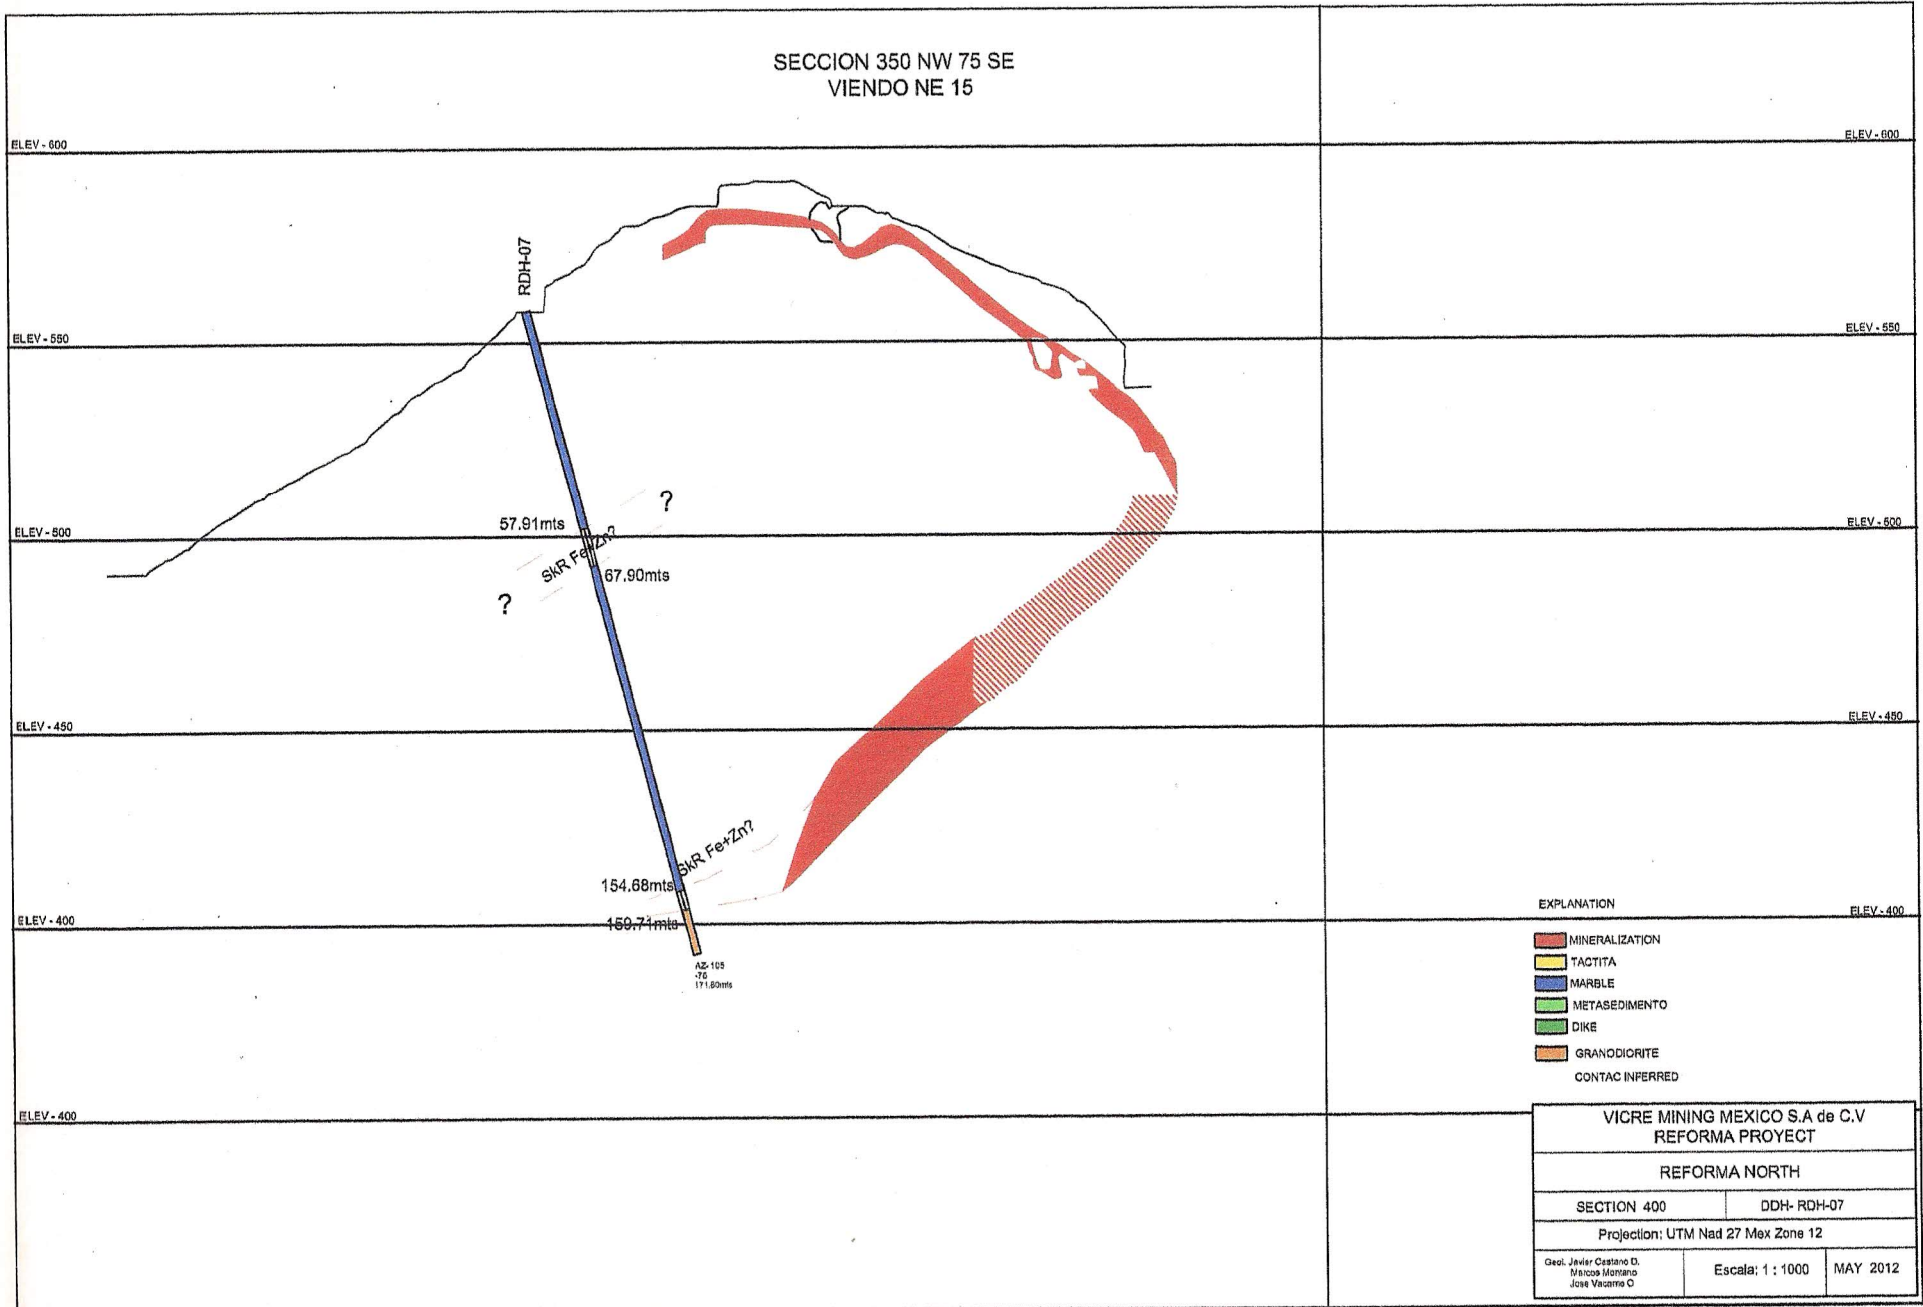
Figure 19. Cross Section Showing RDH 07 (Looking 15°NE)

The drill collar locations are presented in Figure 18. Cross sections showing drill intersections of geological formations and mineralization are presented in Figures 19, 20 and 21.
