Independent Technical Report on the Bethania Silver Project

Department of Huancavelica
Province of Huancavelica, District of Acobambilla, Peru

Report Effective Date: 15 September 2021

Project Number: 590.19.00

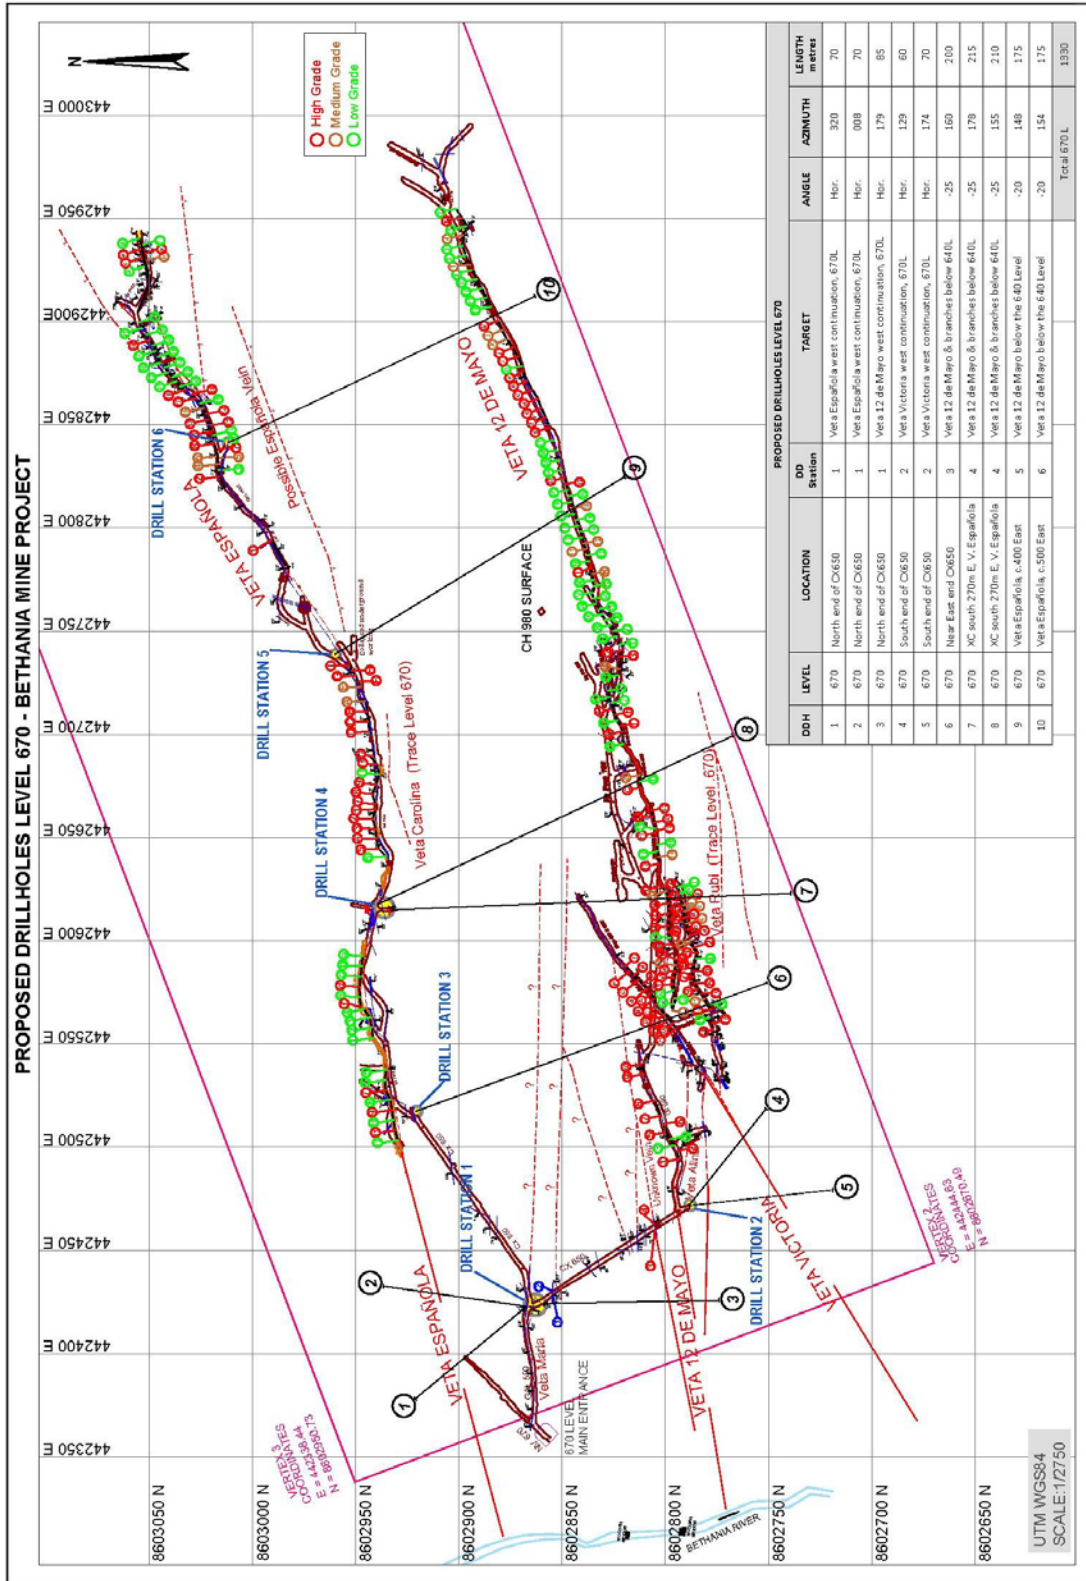
Figure 1-2. Collar locations for the recommended underground diamond drilling program, 670 Level of the Bethania Mine.

Recommended drill hole collar locations for a 20 hole underground diamond drilling program, totalling 2,615 m (Table 1-4) and to be completed from 10 different locations (Table 1-5), are shown in Figure 1-1 and Figure 1-2.

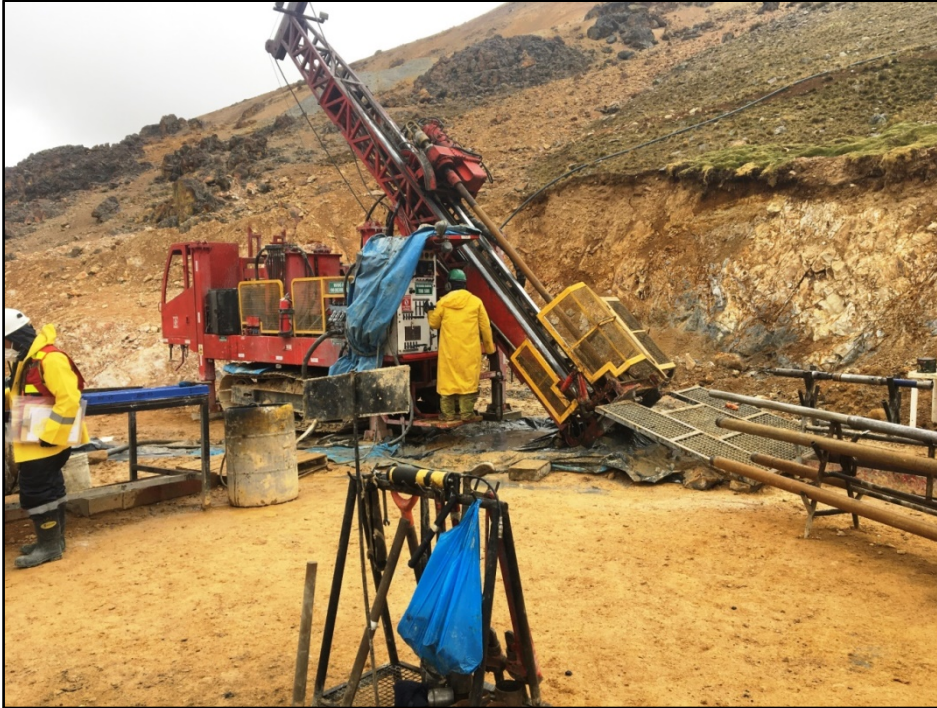
Figure 10-2. Diamond drilling at platform number PLAT-017 and drill hole BDH-35 (source: Simon Mortimer, 2021).

The drilling program began on 16 March 2021 with one drill rig, with an additional drill rig incorporated into the program on 1 April 2021 (Figure 10-2). Drilling took place in two shifts and ran 24 hours per day, seven days per week. Drilling was contracted to Ingeomin S.A.C. (Lima, Peru) with all core drilled in HQ3 (61.1 mm diameter). On completion of each hole, the casing was removed, the hole opening cemented closed, and the location covered with a cement marker (Figure 10-3).

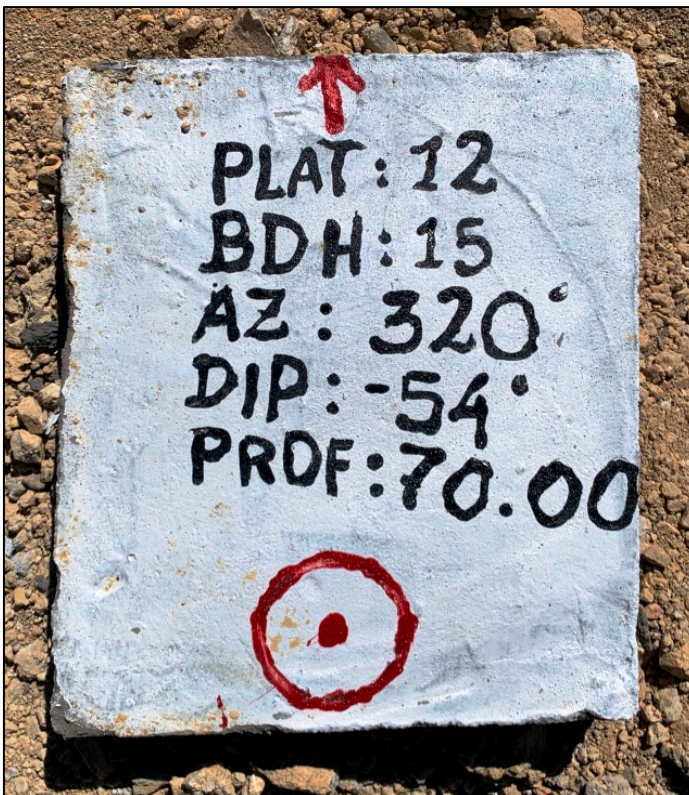
Figure 10-3. Example of cement marker/hole cover with drill hole information placed at each of the drill hole collar locations (source: Kuya Silver, 2021).

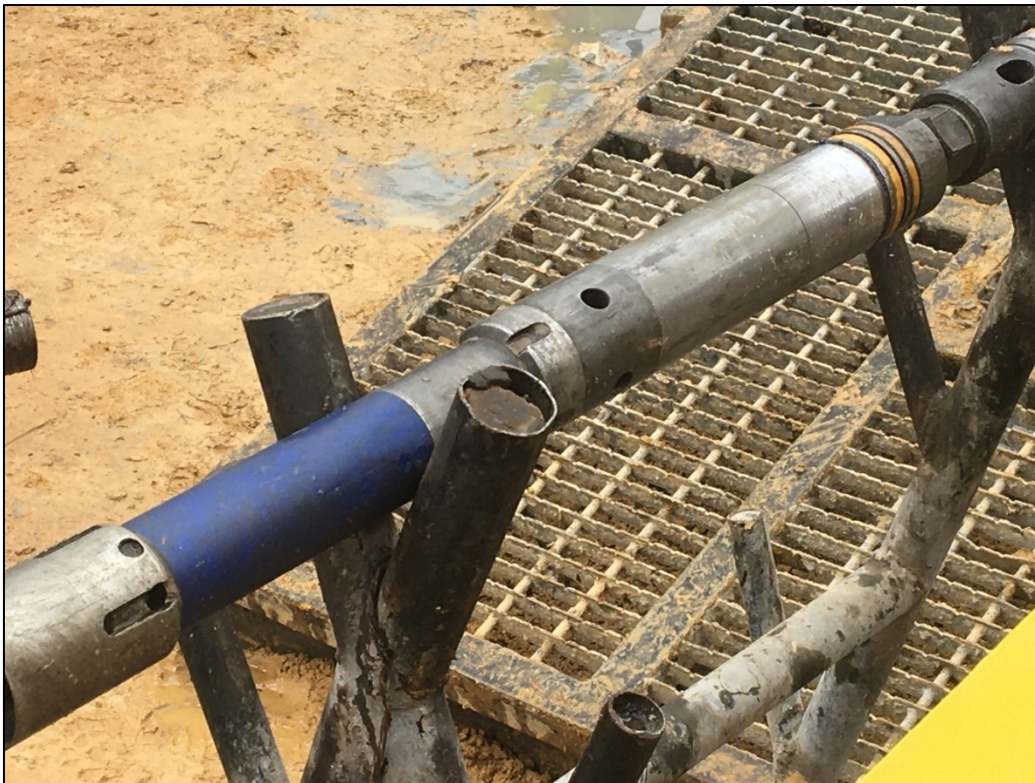
Figure 10-4. Devico downhole DeviGyro multishot survey equipment (source: Simon Mortimer, 2021).

The drilling contractor Ingeomin was responsible for recording the downhole survey, using a DeviGyro multishot surveying tool manufactured by Devico (Figure 10-4), they took downhole deviation measurements approximately every five to twenty-five metres. Measurements were taken with runs down and back up the drill barrel with the average of both runs being used. The survey data extracted from the DeviGyro tool was imported directly into the drilling database.

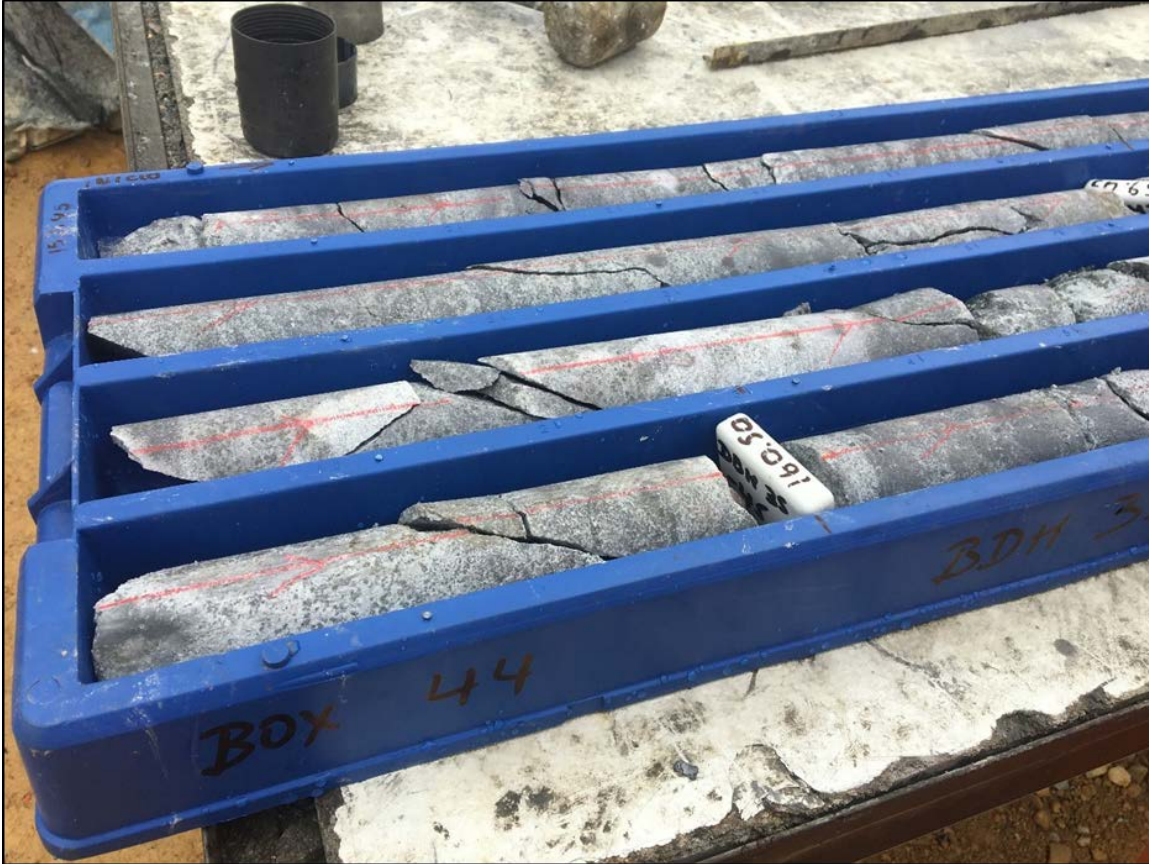
Figure 10-5. Orientated drill core measured using the Devico orientation tools, recorded by the drilling contractors, Ingeomin (source: Simon Mortimer, 2021).

The drilling contractors were also responsible for recording the core orientation, using the Devico core orientation tools they were able to align the top and bottom of the core within the core box (Figure 10-5).

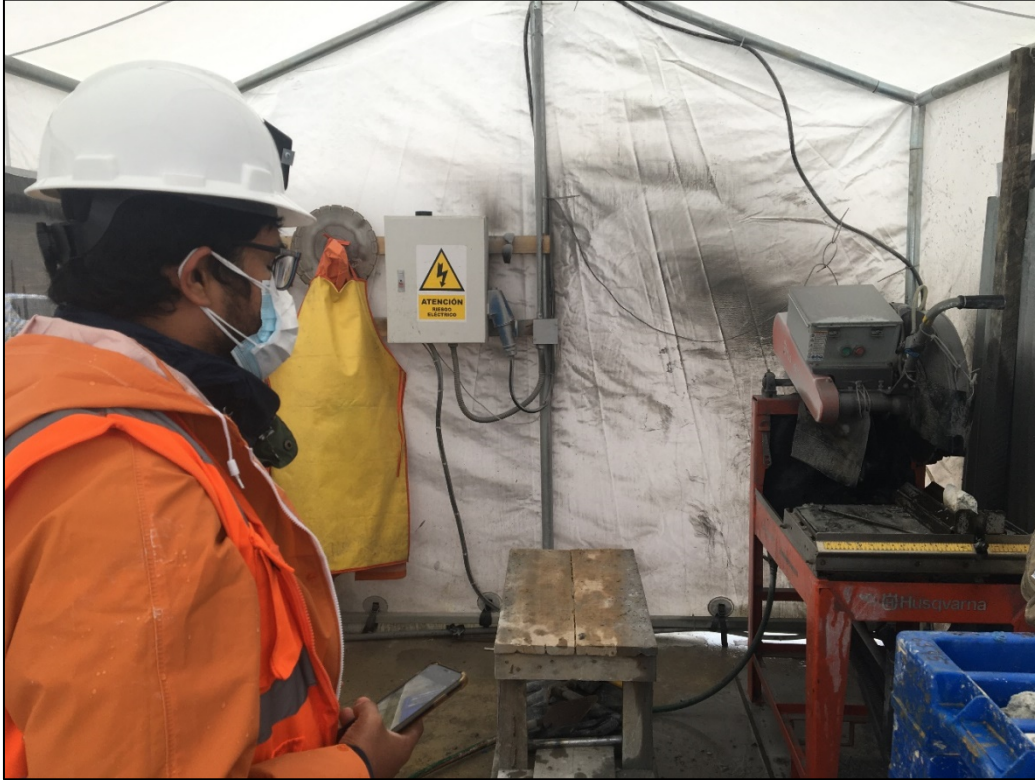
Figure 11-1. The on-site core cutting operation, completed by the geological service providers, BISA. (source: Simon Mortimer, 2021).

Core cutting was completed using a diamond core table saw being careful to re-orient the core back into its original position in the core tray after cutting (Figure 11-1). After each core section was cut and sampled, the diamond saw blade was cleaned using a pumace stone or other cleaning block.

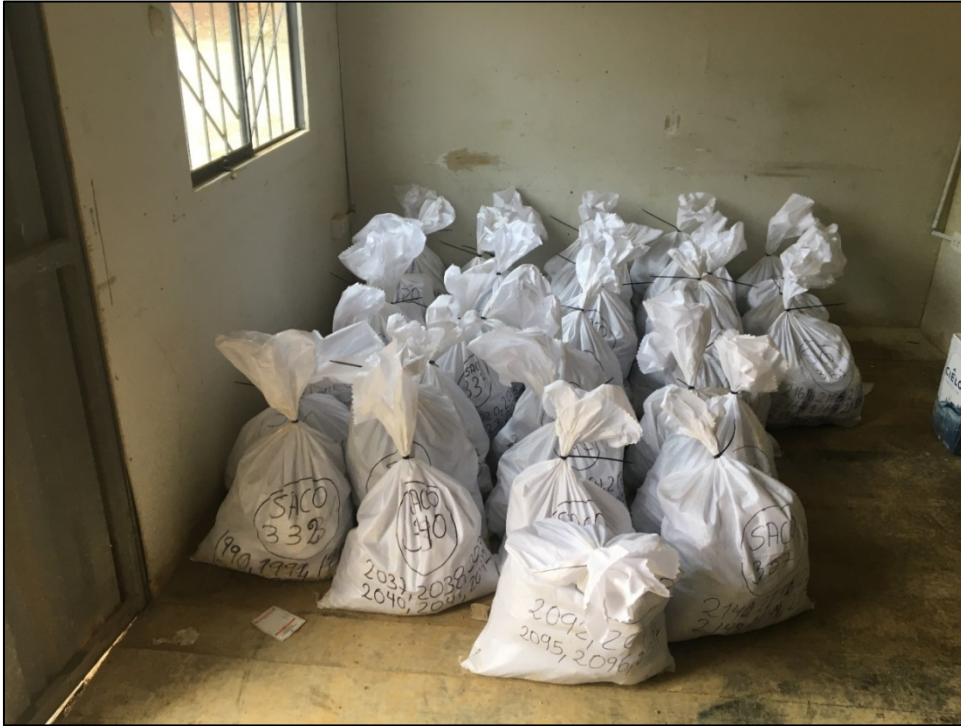
Figure 11-2. The on-site secure sample storage facility with labelled nylon sacks containing the individual samples, ready and waiting shipment to the laboratory in Lima (source: Simon Mortimer, 2021).

After the core was logged and sampled on the Property, it was temporarily stored in a secure warehouse near the core logging facility (Figure 11-2). Core samples were placed in a safe and secure location prior to shipment to the laboratory. Core samples were shipped to SGS Lima by

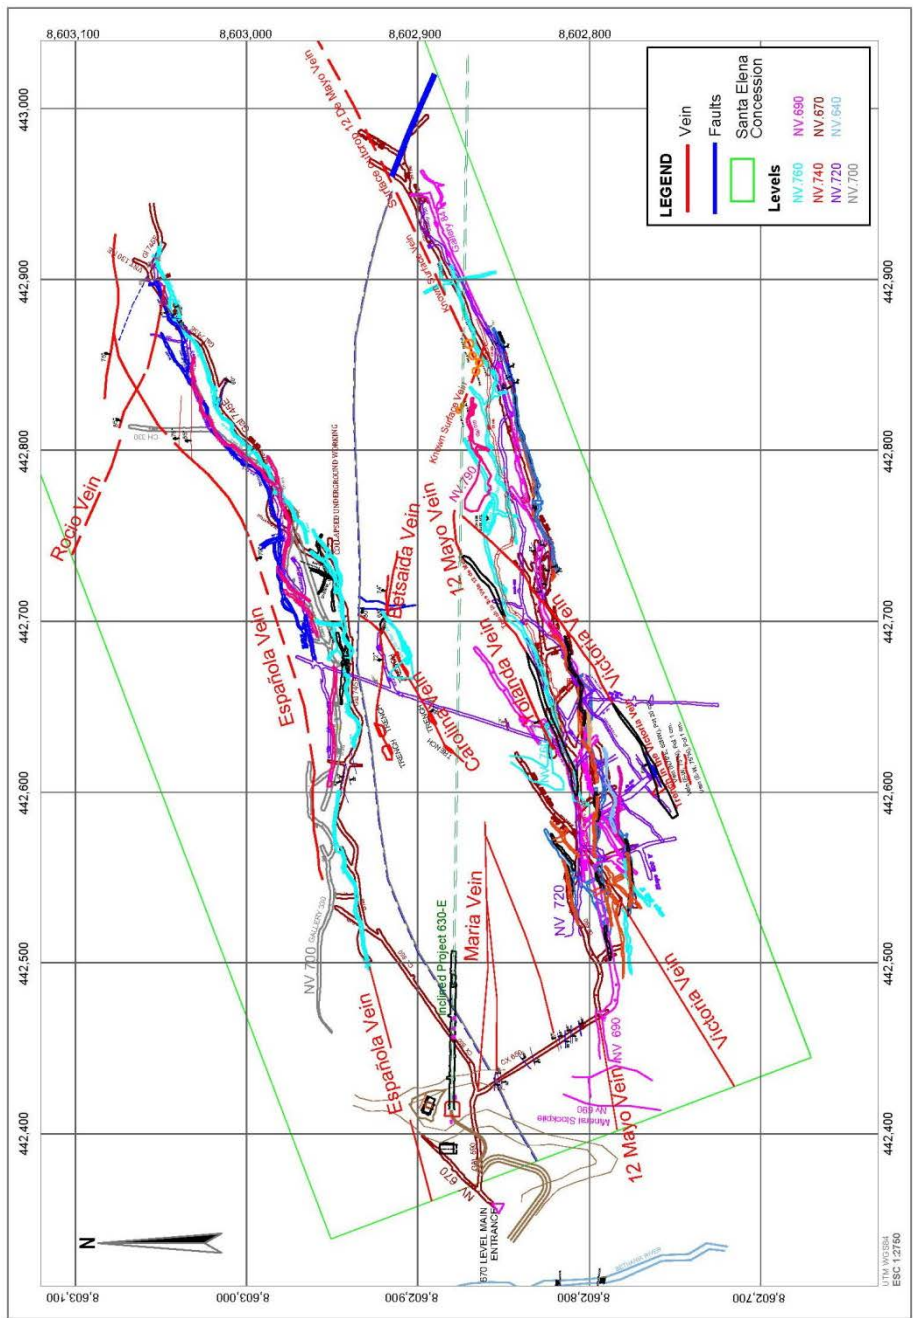
Figure 16-1. Plan map of the historical Mina Santa Elena workings and vein system, Bethania Silver Property.

The historical Mina Santa Elena (now Bethania Mine) has more than 6,500 metres of level development within six different veins. In addition, more than 2,000 metres of raise development was carried out in relation to stope production. Figure 16-1 shows a plan view of the overall level development prior to the suspension of mining operations in 2016.

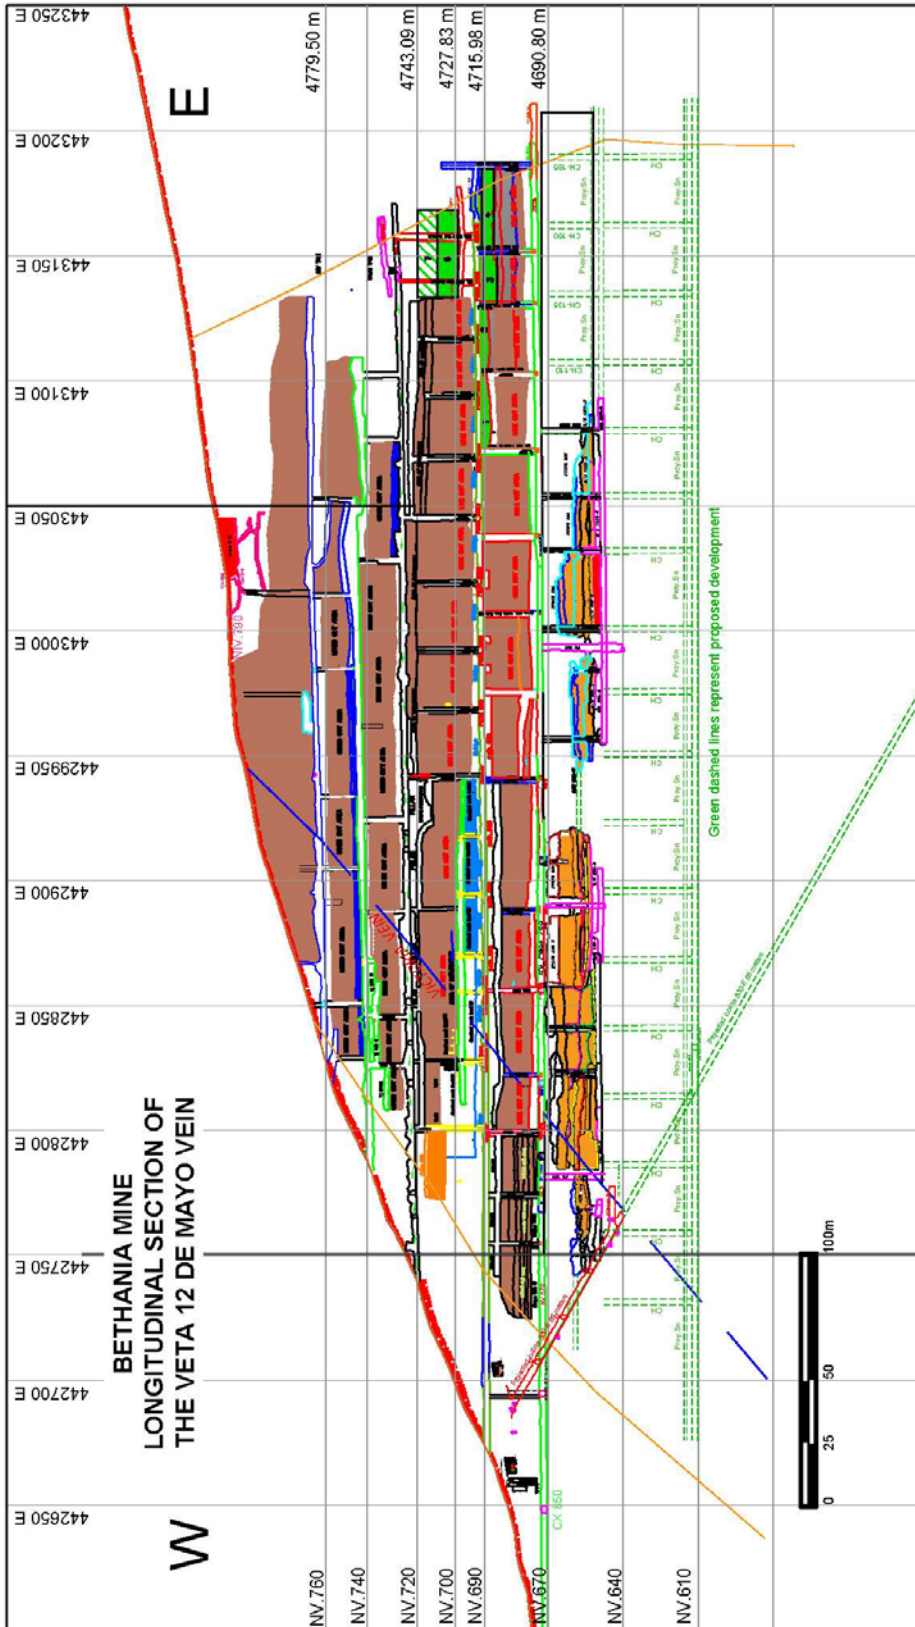
Figure 16-2. Vertical Longitudinal Section of the Veta 12 de Mayo, Bethania Mine.

These mine workings cover an underground area of approximately 650 m by 300 m with level spacing mostly varying from 20 m to 40 m and with the bottom main level (670 Level) accessed horizontally from a surface elevation of 4690 mASL as shown in Figure 16-2, a longitudinal vertical section of the workings on the 12 de Mayo vein.

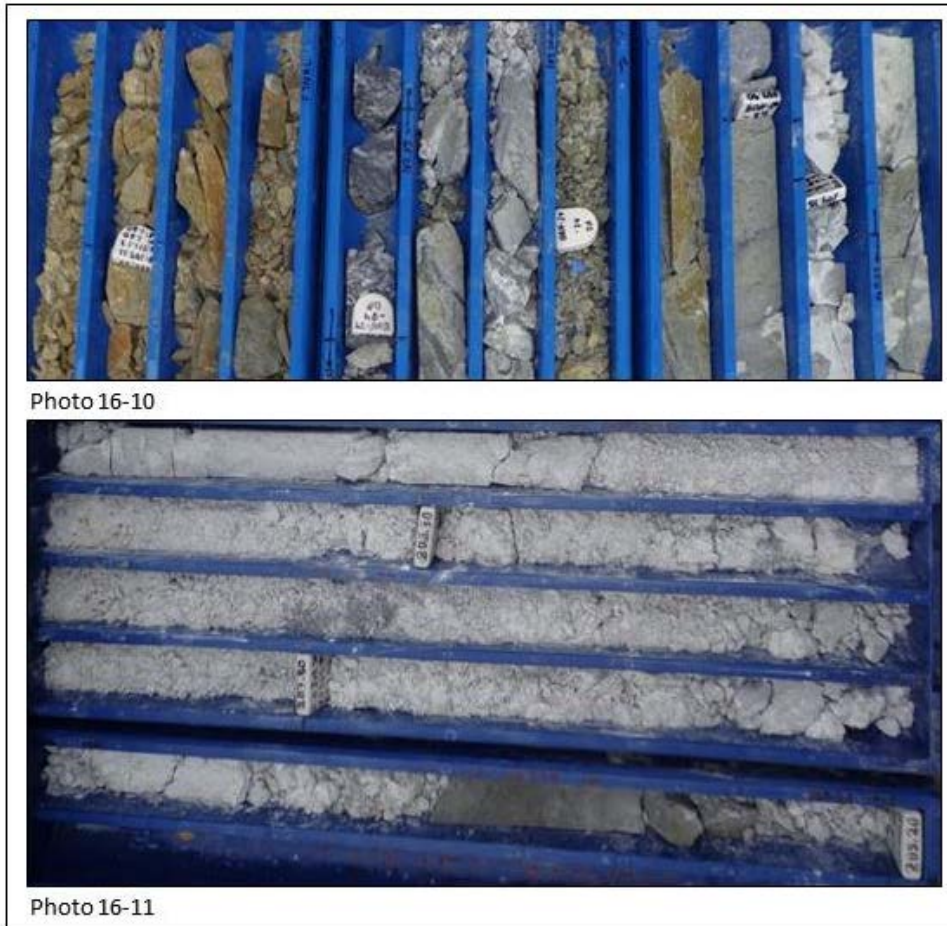
Figure 16-6. Photos 16-10 and 16-11 showing some mineral intercepts for Veta Española. Photo 16-10: Kuya DDH-24: 102.25m to 109.55m Veta Española and altered wall rocks. left-hand 4 m section = footwall-rock rated as “poor”, central 4 m section = broken banded quartz-sulphide veining, right-hand 4 m section = hanging-wall rock rated as “regular”. Photo 16-11: Kuya DDH-02: 201.90 m to 205.2m (end of hole) and the Veta Española. The hanging-wall rock 201.90 m up to the vein intersection is rated as “very poor”. Note: The highly fractured mineral inspected may not be representative of the original rock conditions recovered. Core conditions will have changed during logging and sample cutting, and much movement will have taken place during the 12 hour removal to Kuya’s mineral storage facility in Lima (source: Victor Vargas, Ing.).

Following these observations, minerals from some of the principal vein intersections made during the 2021 Phase 1 drilling campaign, were examined to add further indications as to the overall ground conditions to be expected if mining is resumed at the Bethania Mine. These confirmed that the RMR descriptions ranging "regular" to "poor", were seen throughout the main mineralized intersections, and in at least one case the description would be "very poor". Some examples of the drill core examined are shown in Figure 16-6 (Photos 16-10 and 16-11).

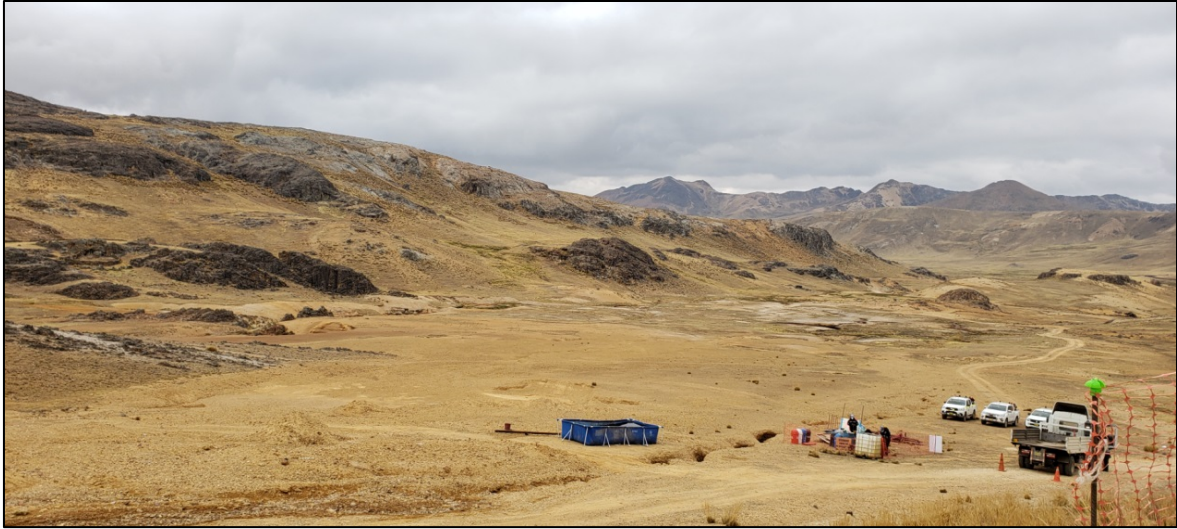
Figure 18-4. Photo of the Tailings Storage Facility proposed site, looking northeast (source: Kuya Silver, 2021).

Figure 18-4 shows the general area where it is proposed to construct the TSF and Figure 18-5 shows the basic design cross section.

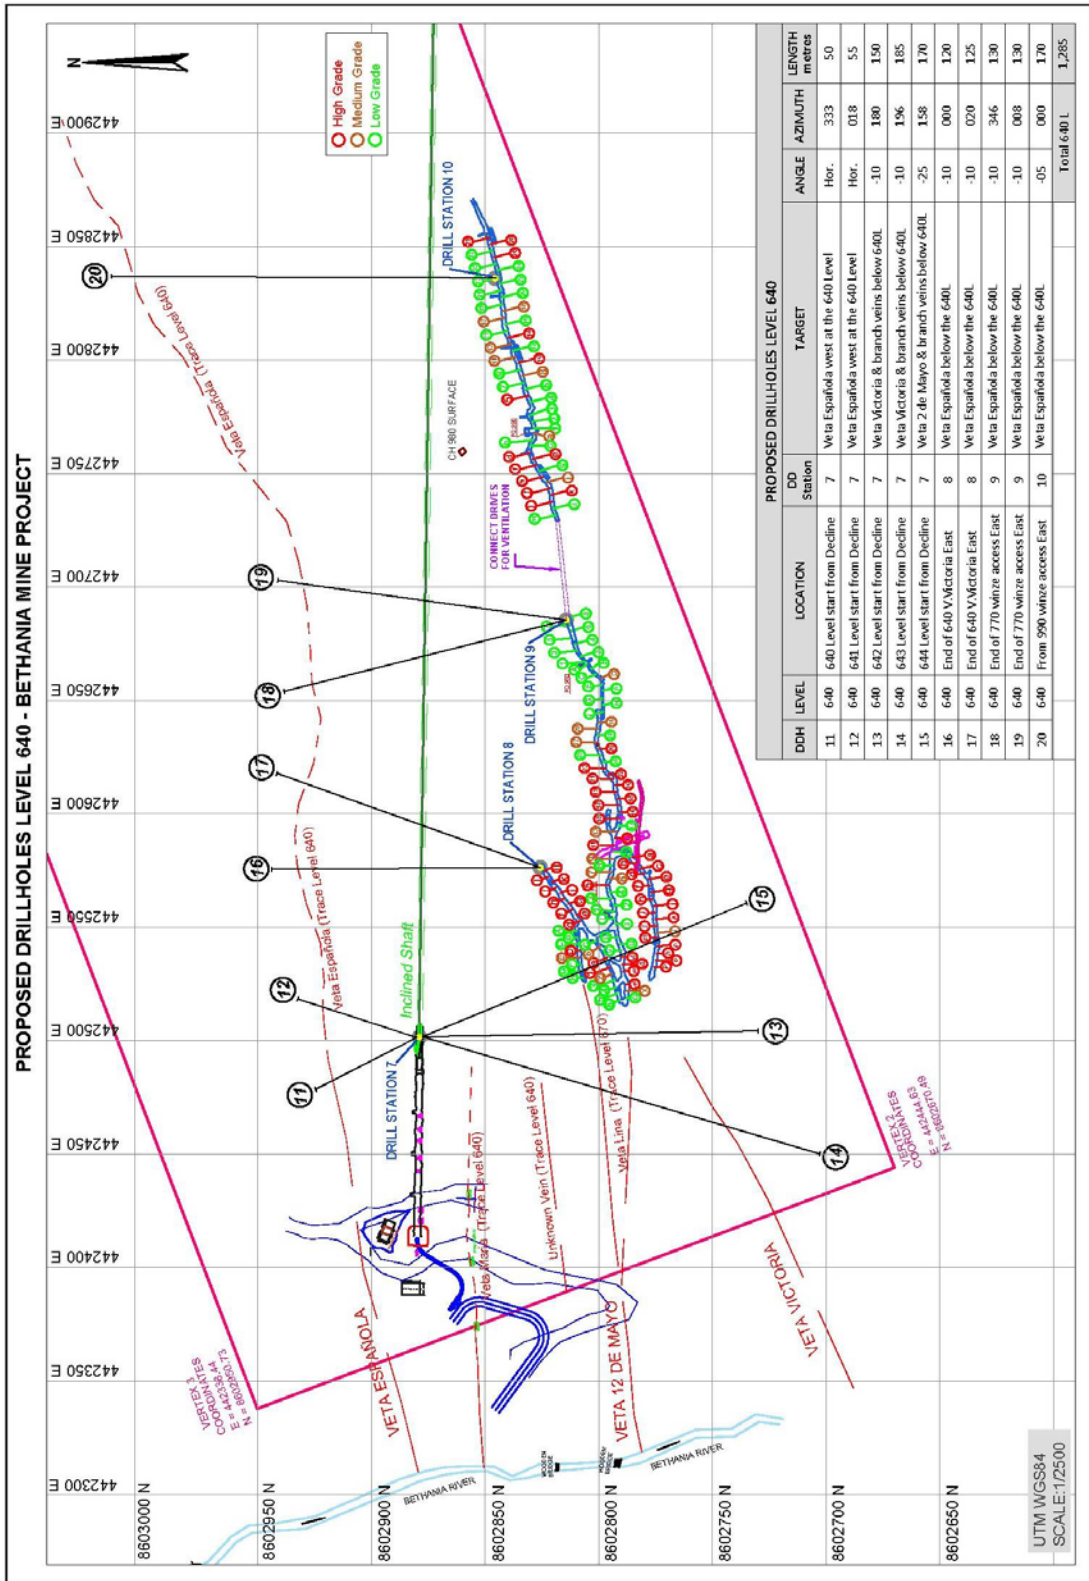
Figure 26-1. Collar locations for the recommended underground diamond drilling program, 640 Level of the Bethania Mine.

Recommended drill hole collar locations for a 20 hole underground diamond drilling program, totalling 2,615 m (Table 26-2) and to be completed from 10 different locations (Table 26-3), are shown in Figure 26-1 and Figure 26-2.
