SAN VICENTE PROJECT
LA LIBERTAD, PERU
NATIONAL INSTRUMENT 43-101F1 TECHNICAL REPORT

Prepared For: Lida Resources Inc.

George C. Sharpe
Geoscience Licensee, A.P.E.G.S.
(With Permission to Consult, P. Geo. (Limited) A.P.G.O)

Effective Date: September 10th, 2019

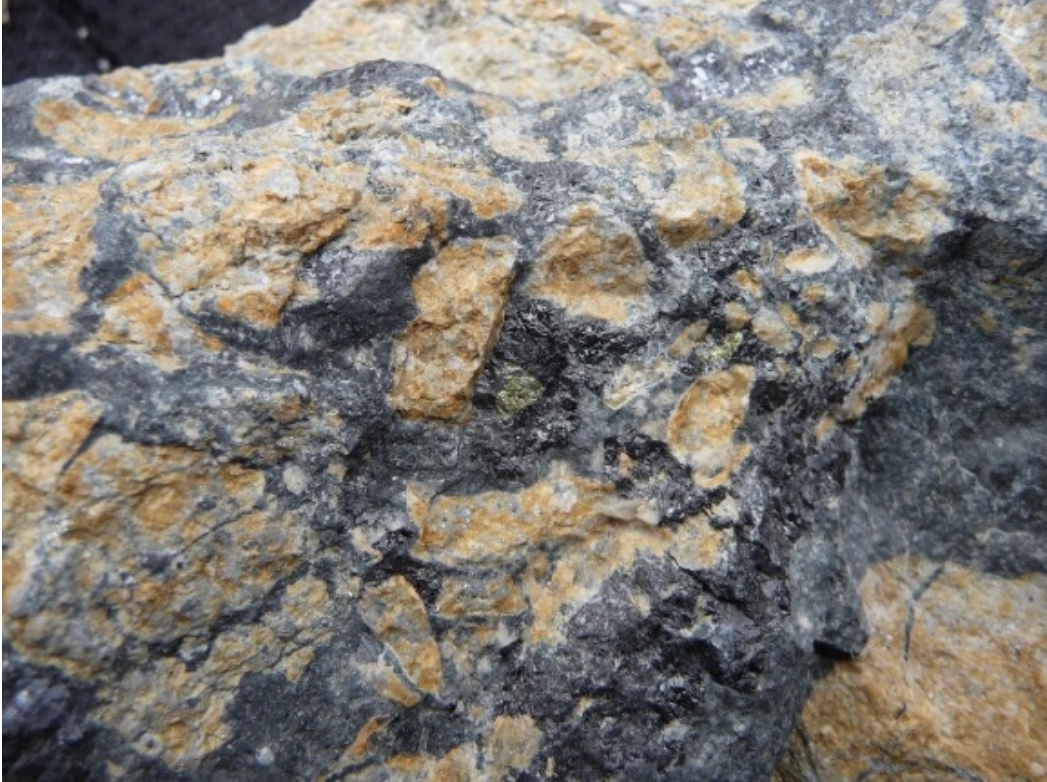
COVER PHOTO:

Andesite breccia displaying angular to sub angular clasts with sphalerite, galena matrix, sample taken from MZ2 structure.

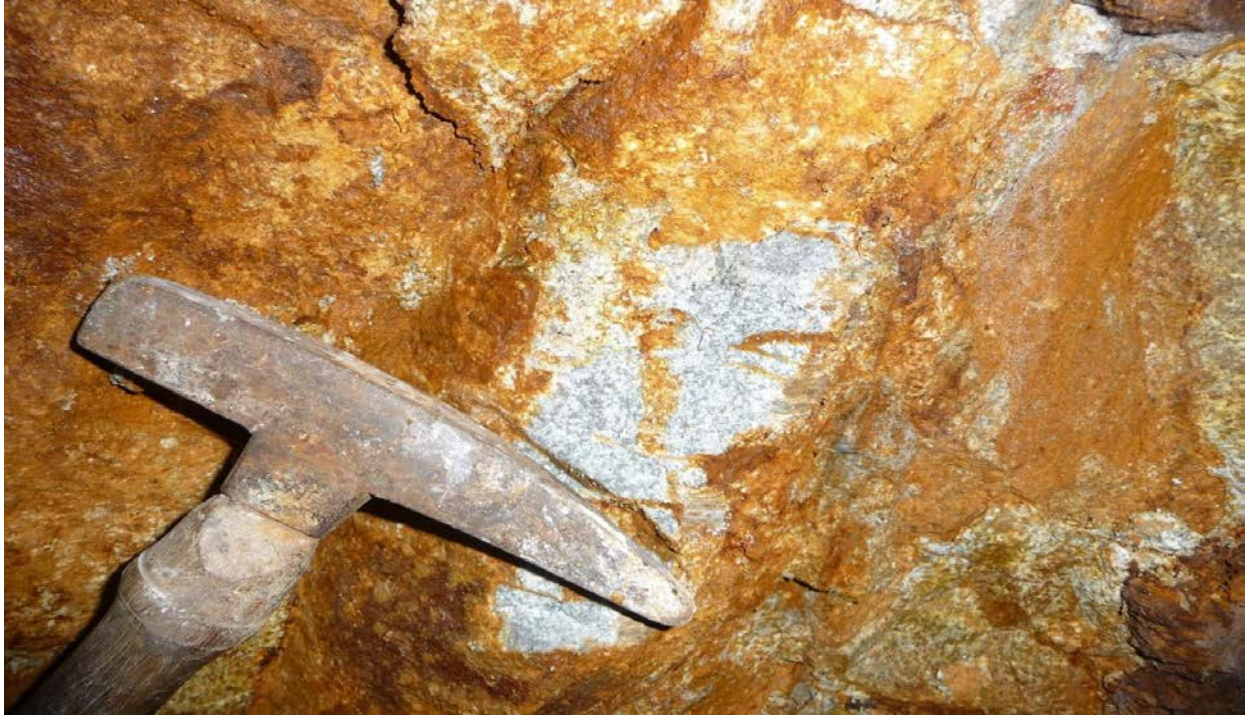
A second type of dioritic rock is also present, as a medium grained rock that is strongly silicified (Figure 7.4). This rock type has probably been intruded as a dyke. The dyke is located approximately 40m into the mine entrance (Figure 7.8).

Figure 7.4: Silicified dioritic rock present as dyke

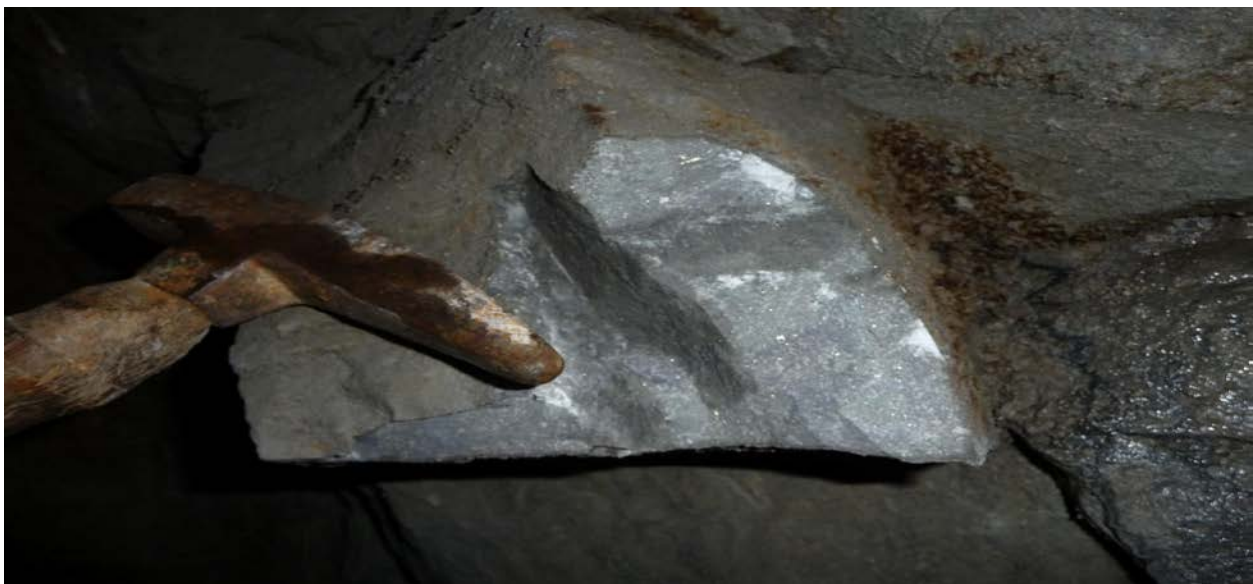
Andesite: The andesite is a massive greenish grey fine to intermediate grained rock with local millimetric sized feldspathic phenocrysts (Figure 7.5). The andesite is hard with some silicification and can contain up to 10% disseminated pyrite.

Figure 7.5: Andesite, greenish-grey fine-grained rock

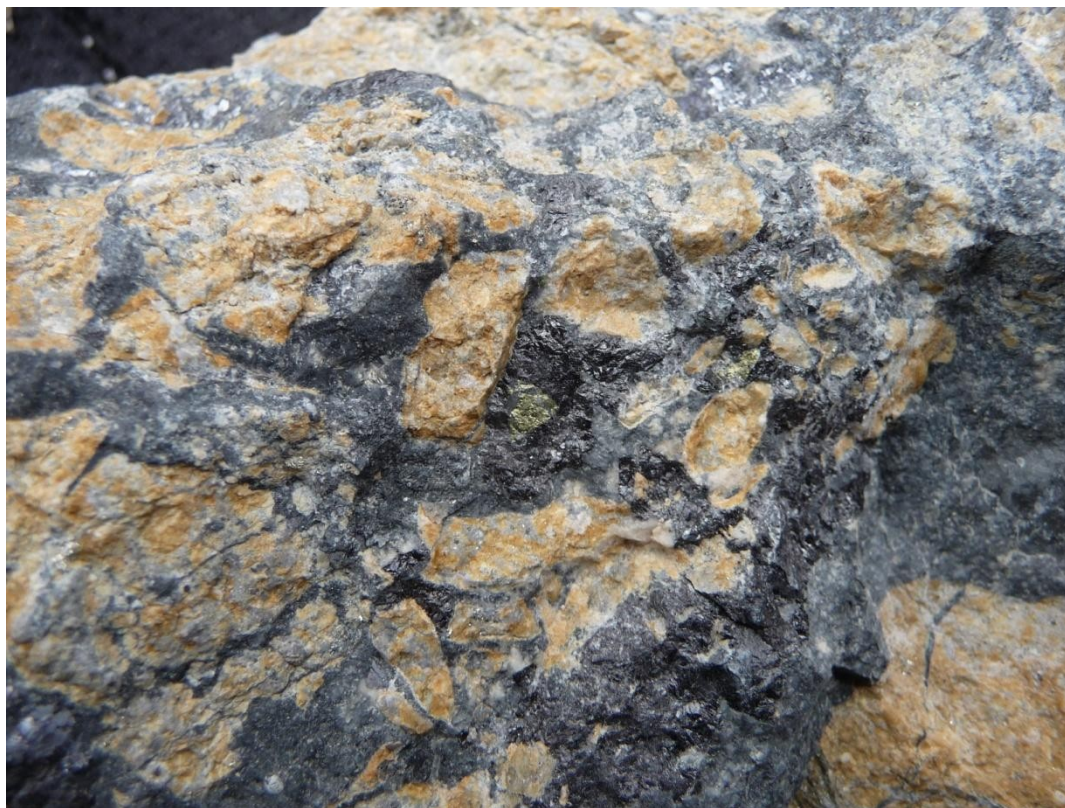
Andesite Breccia: The andesite breccia is a clast supported breccia displaying angular to sub-angular clasts that formed as a result of the intense local brittle fracturing (Figure 7.6). The matrix is composed of calcite and/or rhodochrosite in the un-mineralized structures and of sphalerite and galena within the mineralized structures. The fragments are composed of altered (argillic and/or carbonate) porphyritic andesite.

Figure 7.6: Clast supported breccia displaying angular to sub angular clasts

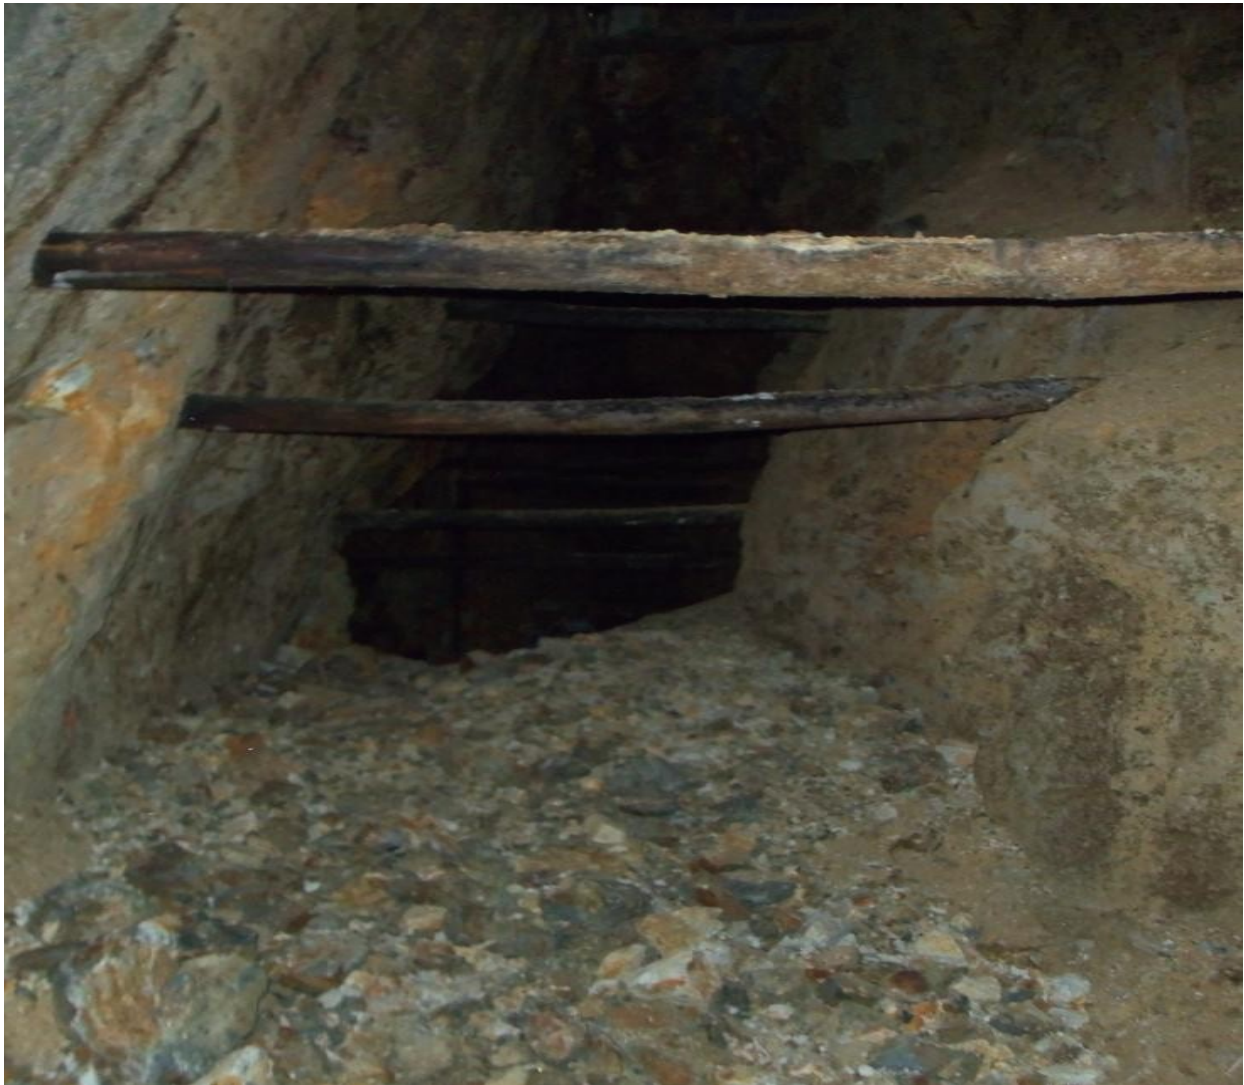
Figure 7.10: Area mined in MZ2 structure

On the main level, twelve channel samples were taken in the southeast part of the vein and eight channel samples were taken on the 105 sub-level above the main 120 gallery. Not all of the main drive along the 120 gallery could be sampled as parts of the drive were mined into the roof (Figure 7.10)

It could be seen from mapping that the vein did open out along strike, however these areas were not available for sampling as the roof was deemed to be too high. Figure 7.10 is a photograph of the vein where its width is approximately 1.2m wide. In Figure 7.10 it can be seen that the footwall is irregular compared to the hanging-wall. This might have some relevance as to why there are low metal values in the immediate footwall compared to the hanging wall in sampling.

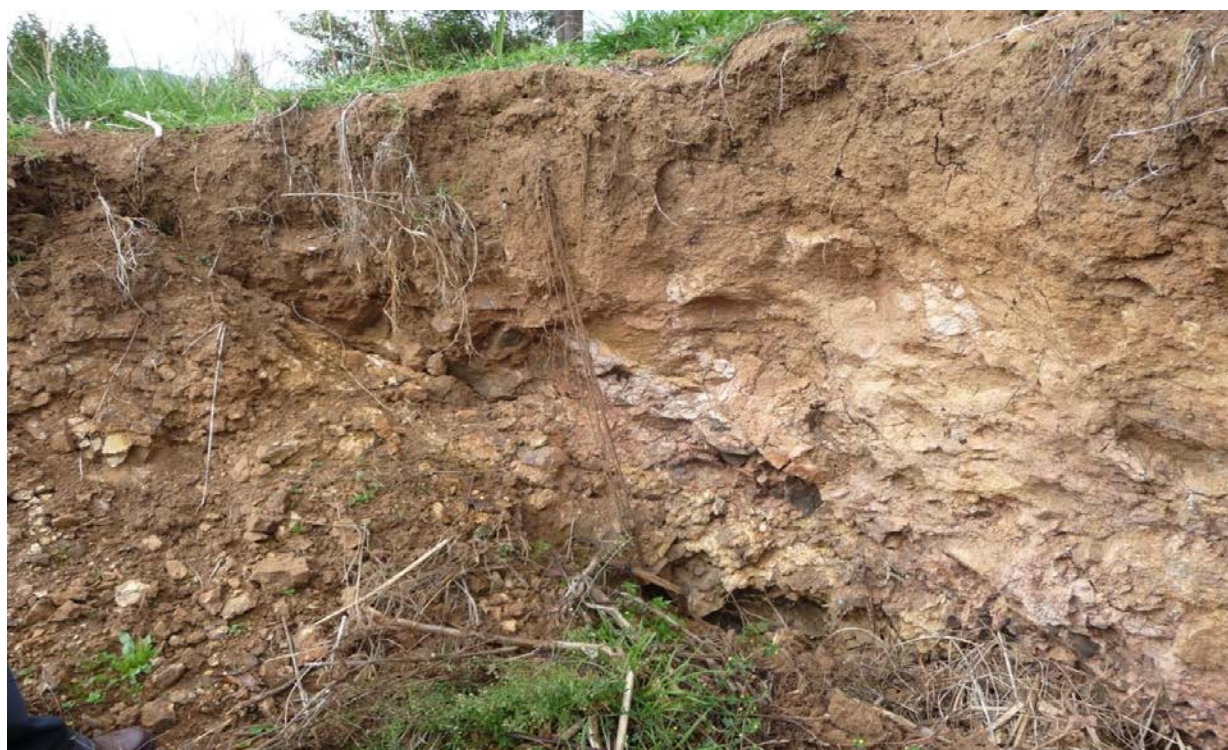
Figure 7.11 Quartz bearing structure in heavily weathered rock and subsoil

During the 2011 site visit, the owner of the land on which this structure is located would not allow access to Carbajal & Whitty S.A.C., or S.M.R.L. staff when doing their mapping program but they indicated to T. Yagua (Chota January 2011) that the structure was Au bearing. Photos taken by T. Yagua (Figures 7.10 and 7.11) show that the surface of this structure had been worked on. Currently, it is the intention of Lida Resources, to make arrangements with the current surface rights holders to obtain permission to access the areas to be explored in the initial programs (Stages 0 and 1), and to acquire permits to carry on the more advanced work (Stage 2) when that is required.

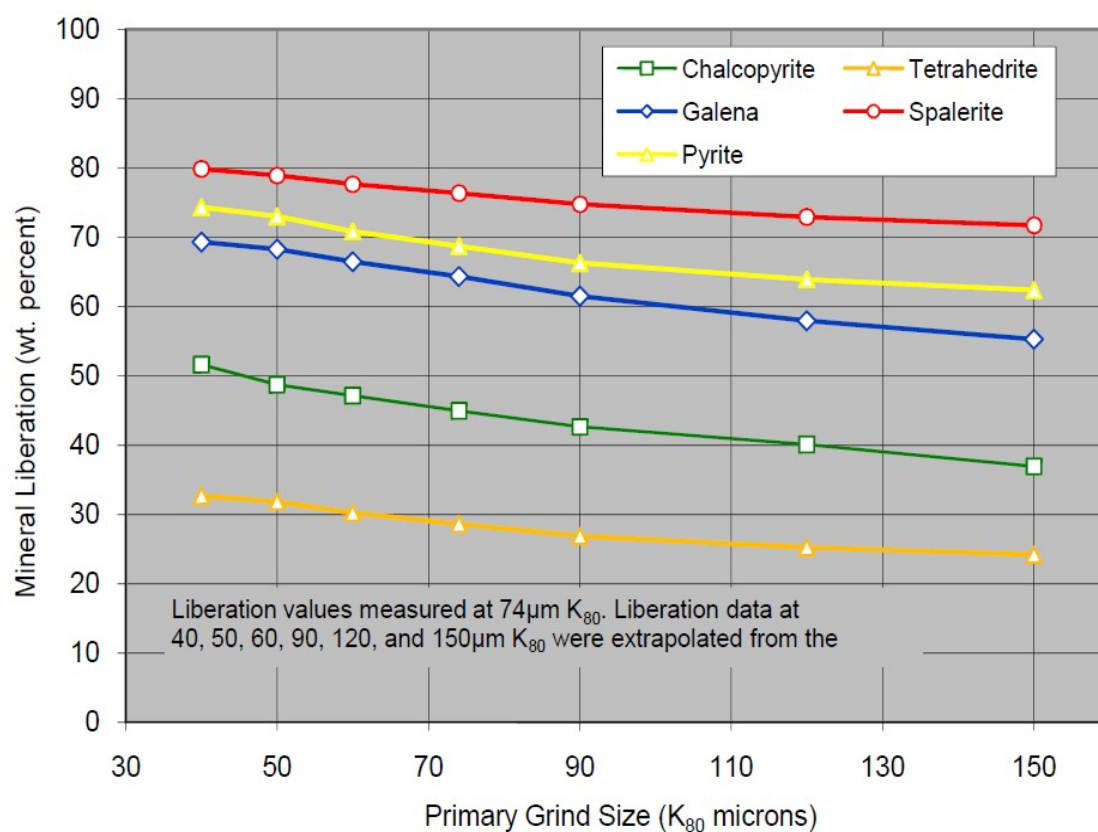
Figure 13.2: Effect of primary grind size on mineral liberation

The primary grind sizing, across the range evaluated, had little effect on the liberation of sulphide minerals. It was therefore concluded that in order to significantly increase mineral liberation values, a major change in grinding sizing would be required.

The fragmentation data can be manipulated to estimate the effect of primary grind size on mineral liberation (Figure 13.2).
