SAN VICENTE PROJECT
LA LIBERTAD, PERU
NATIONAL INSTRUMENT 43-101F1 TECHNICAL REPORT

Prepared For: Lida Resources Inc.

George C. Sharpe
Geoscience Licensee, A.P.E.G.S.
(With Permission to Consult, P. Geo. (Limited) A.P.G.O)

Effective Date: September 10th, 2019

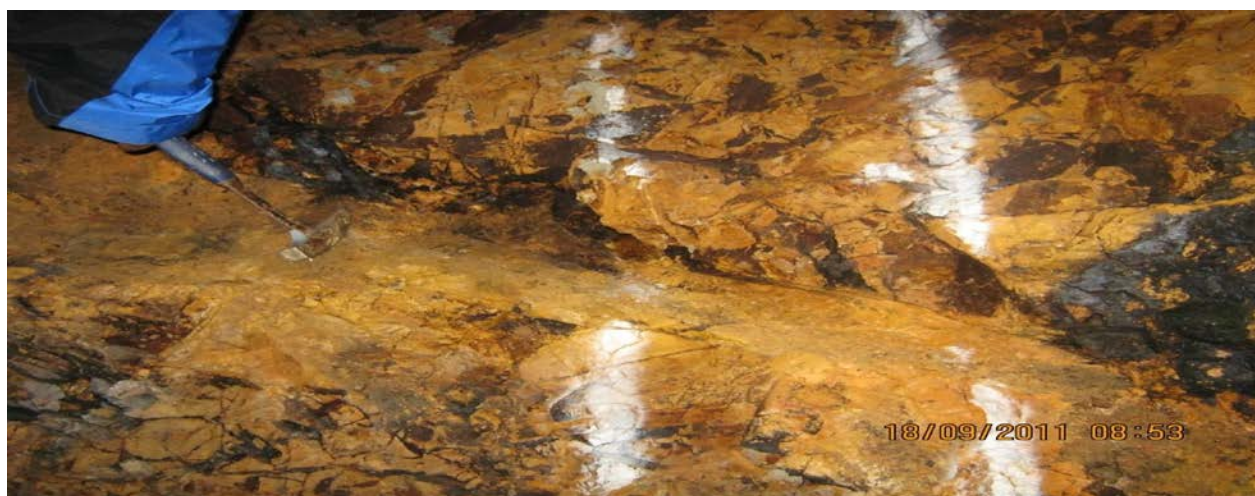
Diorite: Rusty orange medium grained equigranular strongly altered dioritic rock (Figure 7.3). The diorite has undergone intense brittle deformation and alteration. The plagioclase crystals and matrix have been completely altered to an assemblage of clay minerals resulting in the loss of most of the rocks competency. Relict textures indicate that the protolith was most likely diorite. The rocks rusty orange colour results from iron carbonate staining. The diorite was found in the main crosscut of the underground mine and in many areas during surface mapping.

Figure 7.3: Rusty orange medium grained equigranular strongly altered dioritic rock

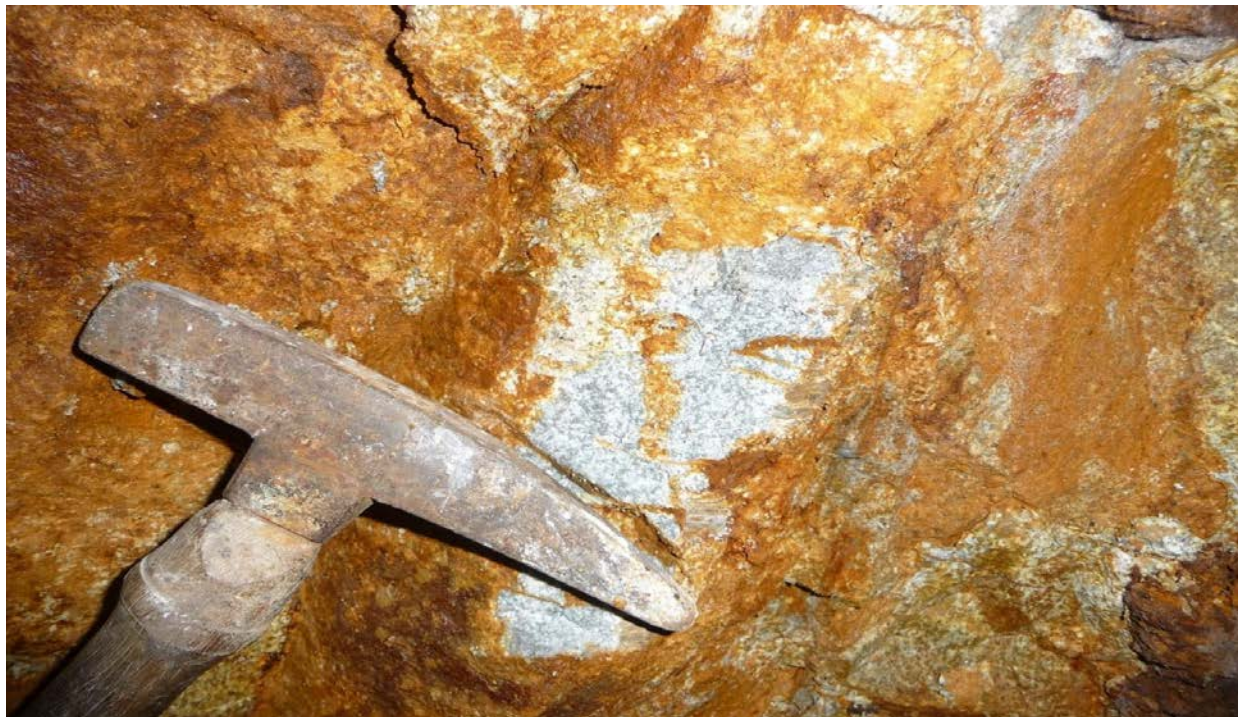
A second type of dioritic rock is also present, as a medium grained rock that is strongly silicified (Figure 7.4). This rock type has probably been intruded as a dyke. The dyke is located approximately 40m into the mine entrance (Figure 7.8).

Figure 7.4: Silicified dioritic rock present as dyke

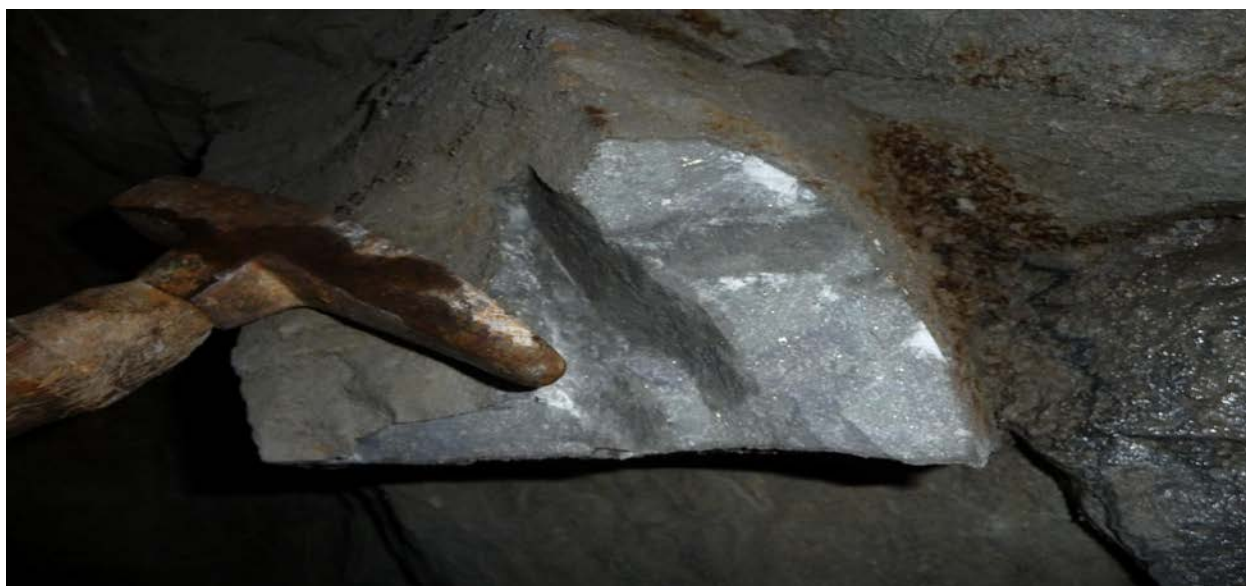
Andesite: The andesite is a massive greenish grey fine to intermediate grained rock with local millimetric sized feldspathic phenocrysts (Figure 7.5). The andesite is hard with some silicification and can contain up to 10% disseminated pyrite.

Figure 7.5: Andesite, greenish-grey fine-grained rock

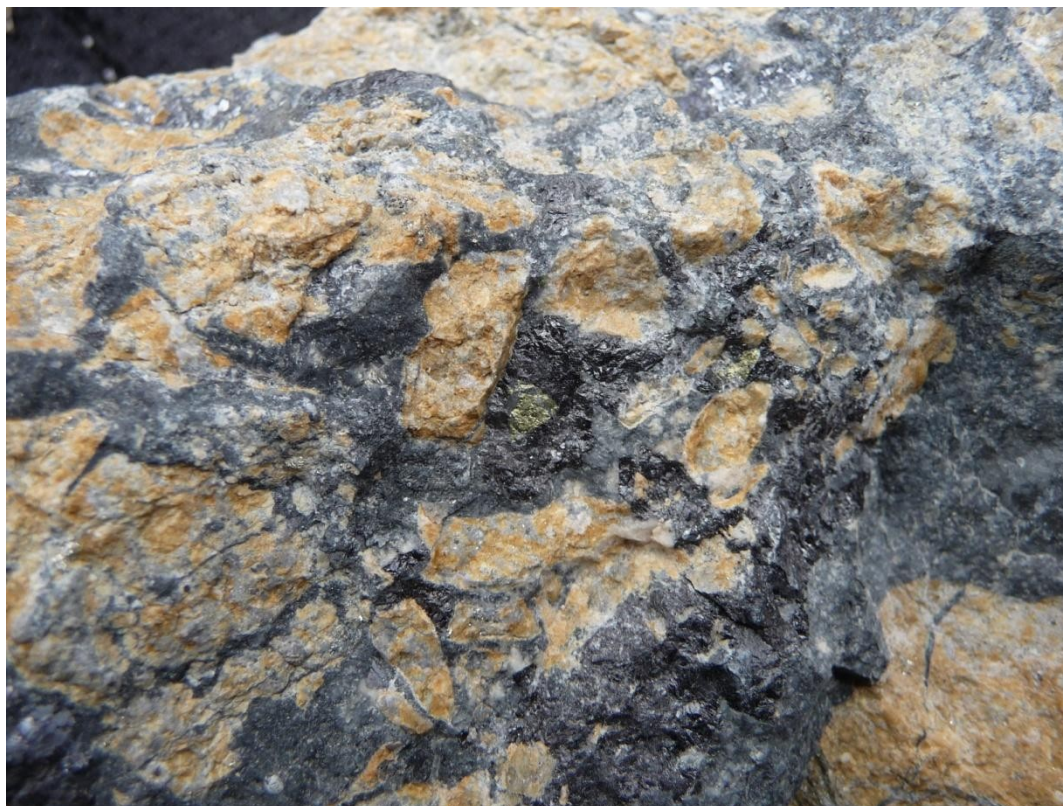
Andesite Breccia: The andesite breccia is a clast supported breccia displaying angular to sub-angular clasts that formed as a result of the intense local brittle fracturing (Figure 7.6). The matrix is composed of calcite and/or rhodochrosite in the un-mineralized structures and of sphalerite and galena within the mineralized structures. The fragments are composed of altered (argillic and/or carbonate) porphyritic andesite.

Figure 7.6: Clast supported breccia displaying angular to sub angular clasts

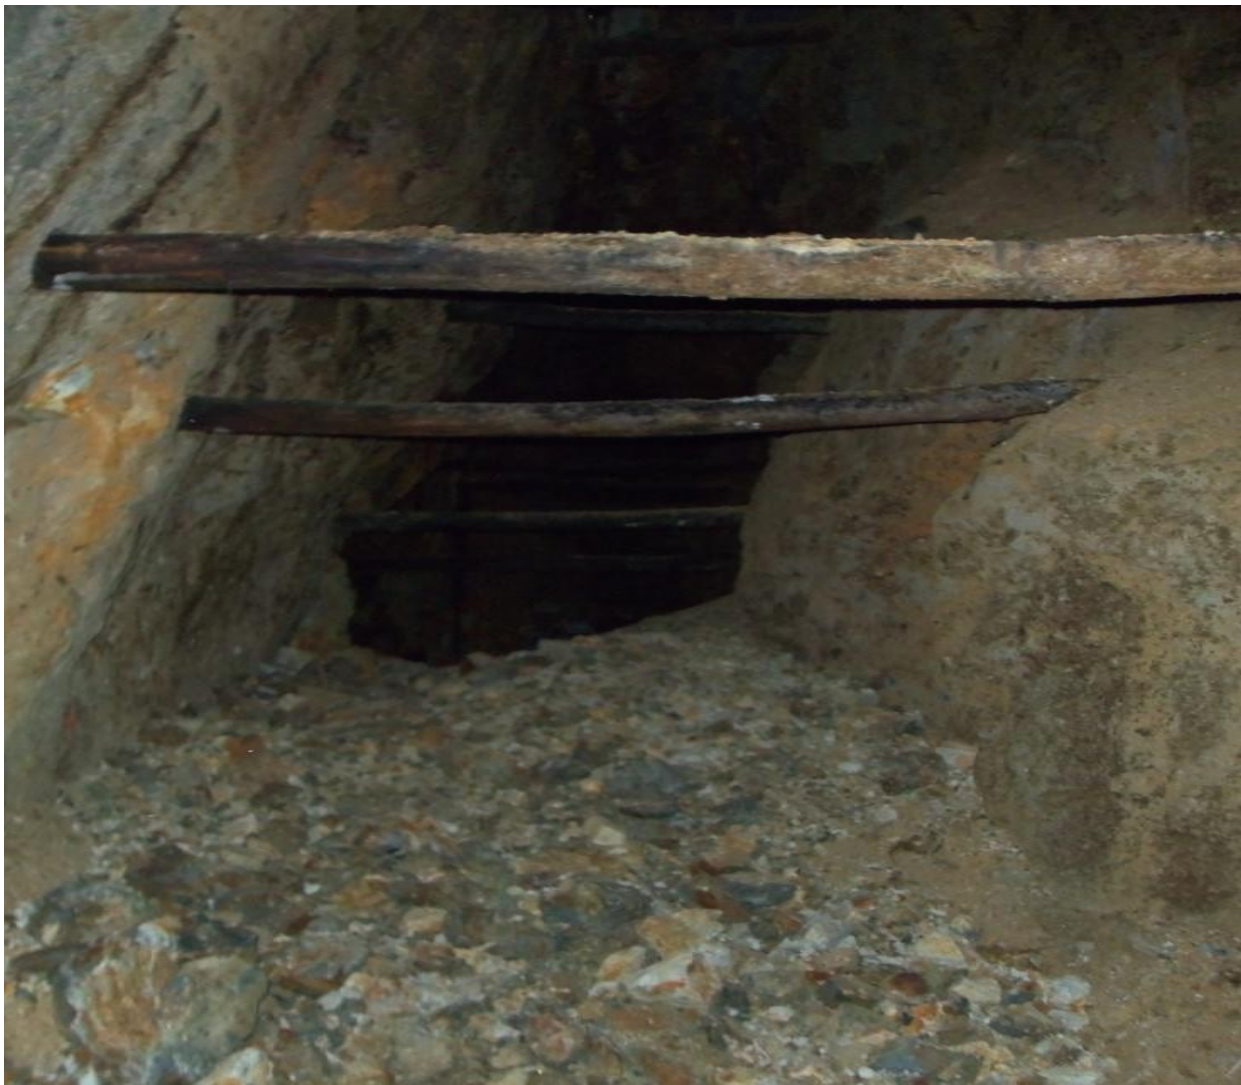
Figure 7.10: Area mined in MZ2 structure

On the main level, twelve channel samples were taken in the southeast part of the vein and eight channel samples were taken on the 105 sub-level above the main 120 gallery. Not all of the main drive along the 120 gallery could be sampled as parts of the drive were mined into the roof (Figure 7.10)

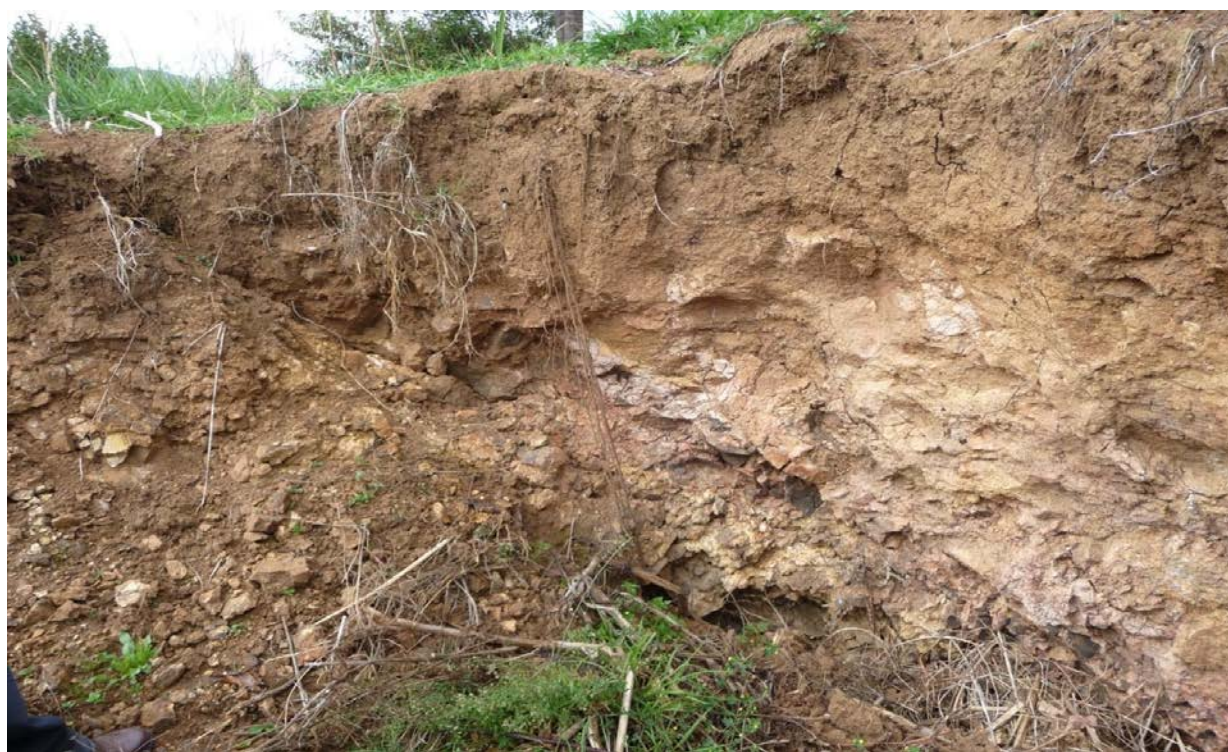
Figure 7.11 Quartz bearing structure in heavily weathered rock and subsoil

During the 2011 site visit, the owner of the land on which this structure is located would not allow access to Carbajal & Whitty S.A.C., or S.M.R.L. staff when doing their mapping program but they indicated to T. Yagua (Chota January 2011) that the structure was Au bearing. Photos taken by T. Yagua (Figures 7.10 and 7.11) show that the surface of this structure had been worked on. Currently, it is the intention of Lida Resources, to make arrangements with the current surface rights holders to obtain permission to access the areas to be explored in the initial programs (Stages 0 and 1), and to acquire permits to carry on the more advanced work (Stage 2) when that is required.

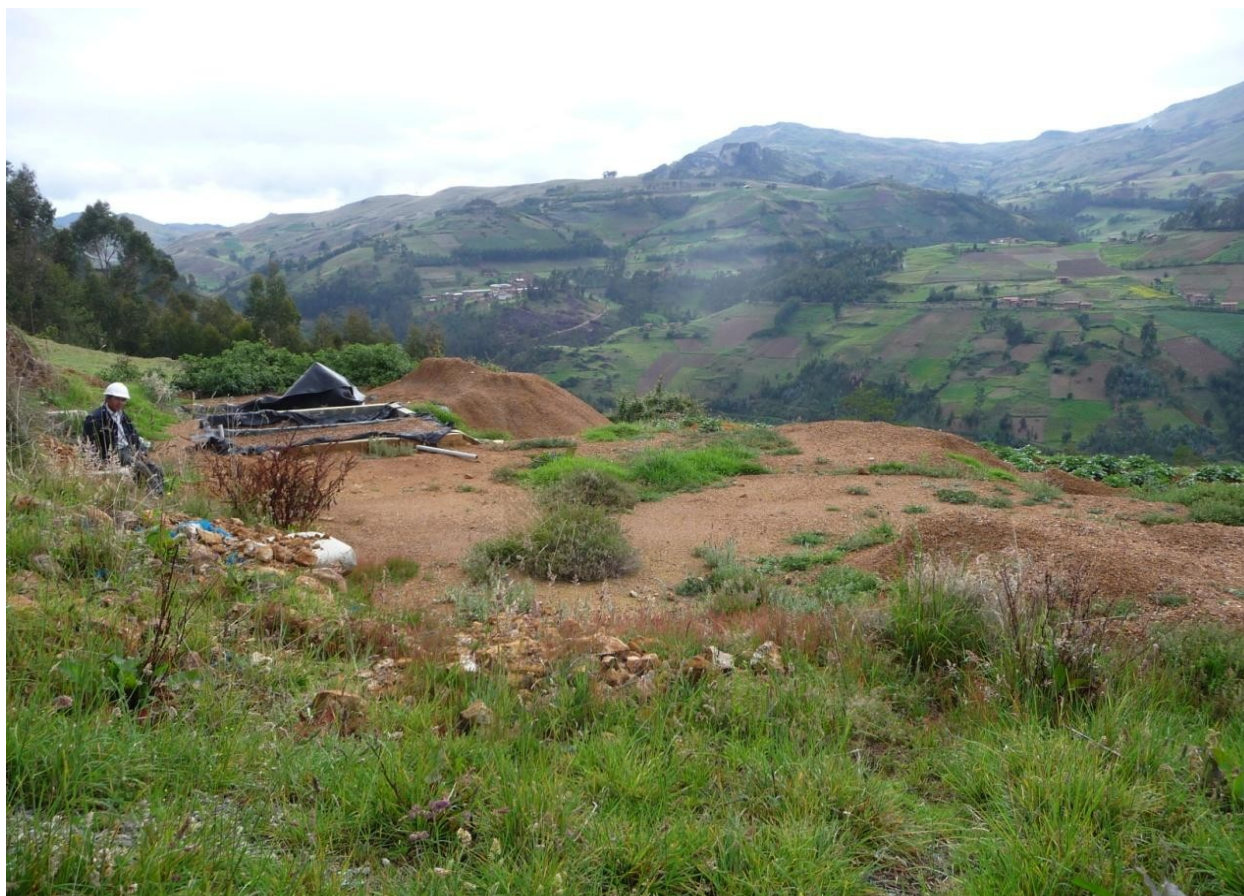
Figure 7.12: Areas excavated along strike of MZ4 structure

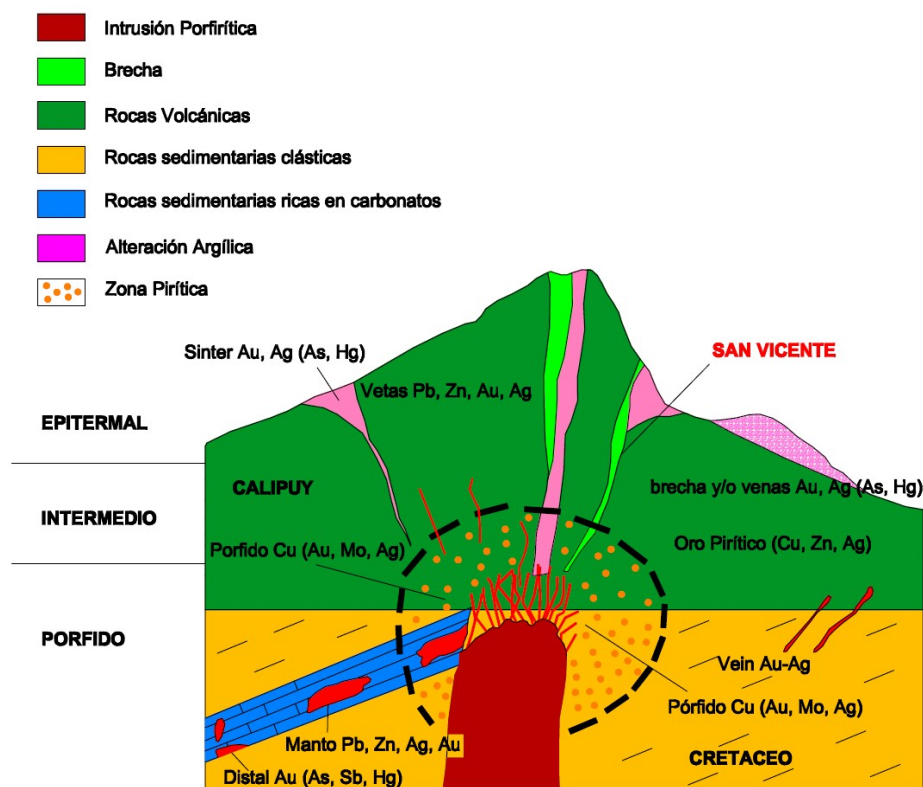
Figure 8.1: Schematic representing the relationship between various hydrothermal deposit types

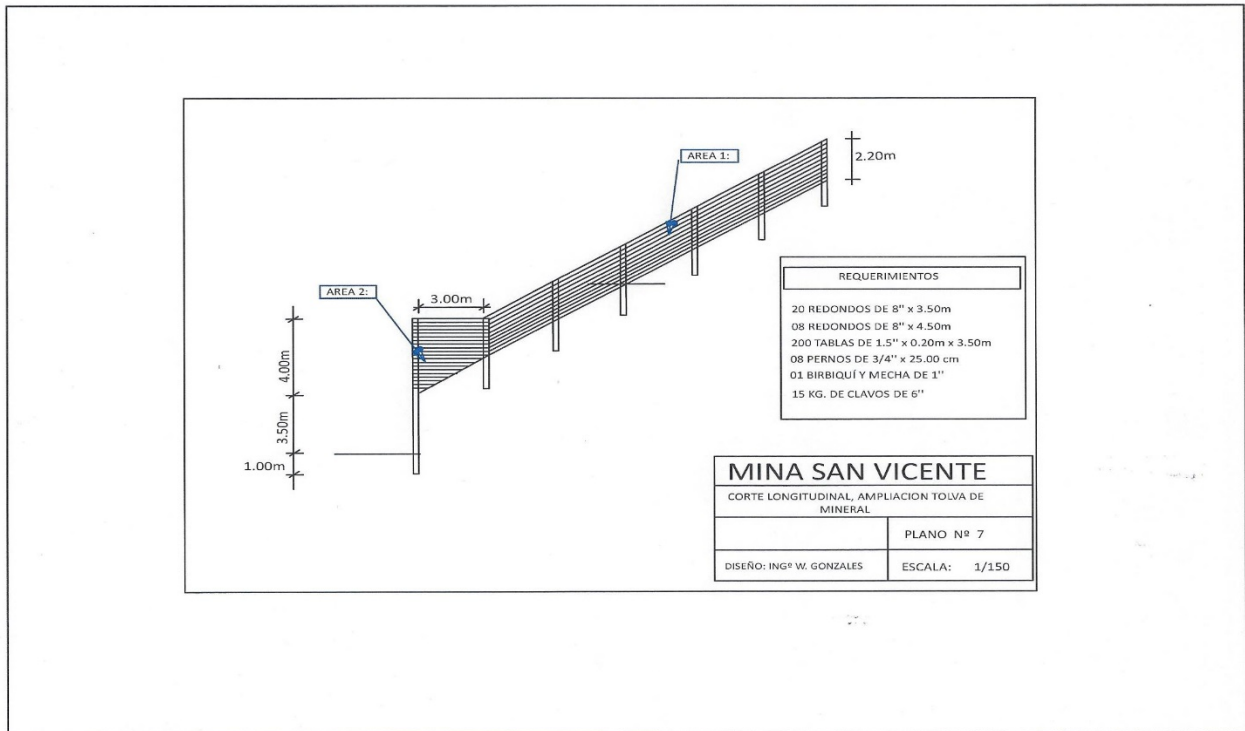
Figure 9.8: Longitudinal Section of the Mineral Hopper

Included below are the results of the topographic survey and mine plan studies conducted on the San Vicente property during 2019. Figures 9.1 through 9.12 represent the topographic survey and geological studies commissioned by Lida Resources on the San Vicente property (see note 6 of table 9.1 above re: "Geology Lab and other fees").

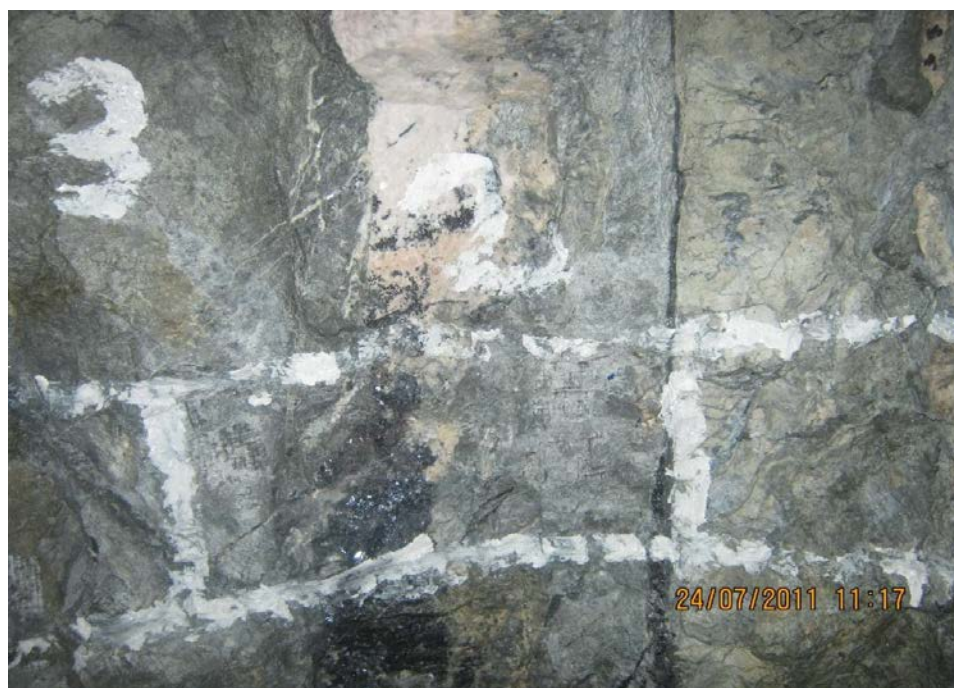
The 2011 sampling appears to be of good quality. The faces were fresh and tool marks could be observed on the rock surface (Figure 11.3). Sample weight was between 1.5 and 2kg. A photographic database exists of most of the channel samples taken. However, for future sampling, a semi mechanical method is recommended (Recommendation in Section 18).

Figure 11.3: Typical channel sample

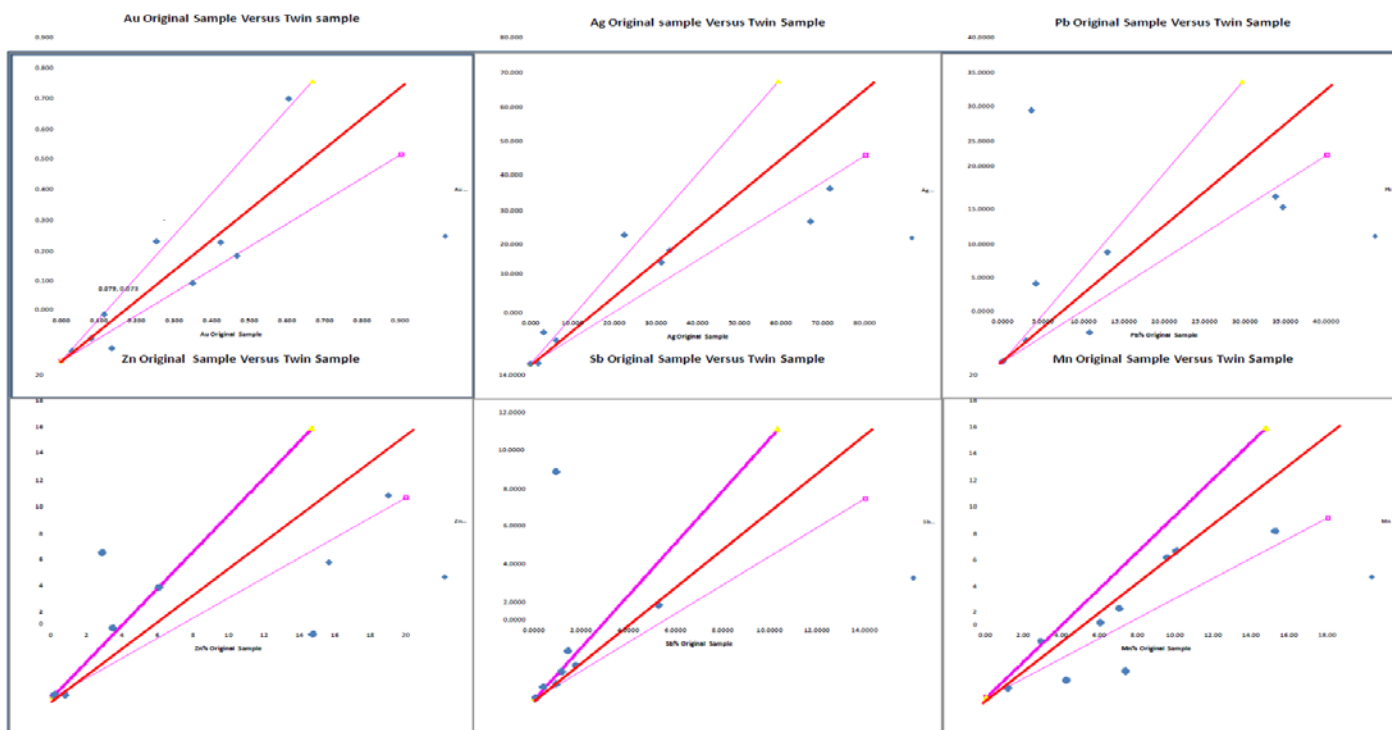
Figure 12.1: Results of twin samples

Only 9 twin samples were taken, however it was noted that not all the twin samples returned within the given tolerance limit of 15% difference between original and twin samples (Figure 12.1 showing results). This could be due to two reasons:

1. Sample widths were too small in some areas resulting in samples that did not recover sufficient material.
2. The style of mineralization in some areas made extracting twin samples difficult. For example, if the sampler took a twin sample parallel to the sample taken in Figure 12.1, this would result in two completely different assays as it can be seen that the change in mineralization within the vein is sharp from predominantly polymetallic mineralization to rhodochrosite.

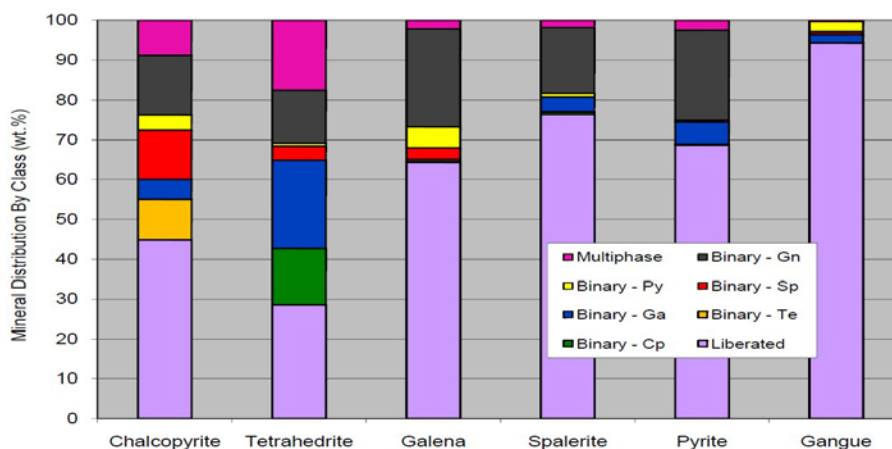
Figure 13.1: Mineral distribution by class of association – grab sample - 74 μ m K80

The galena and sphalerite particles were well liberated at 64% and 76% respectively. The majority of unliberated particles were present in binary form with non-sulphide gangue minerals. Both galena and sphalerite gangue binary minerals were rich in galena and sphalerite respectively and both are expected to be recovered by flotation.

The Particle Mineral Analysis (PMA) using QEMSCAN was conducted on the sample ground to 74 μ m K80. The result of this analysis revealed the mineral content and fragmentation characteristics. The results are presented in Table 13.2 and Figure 13.1.

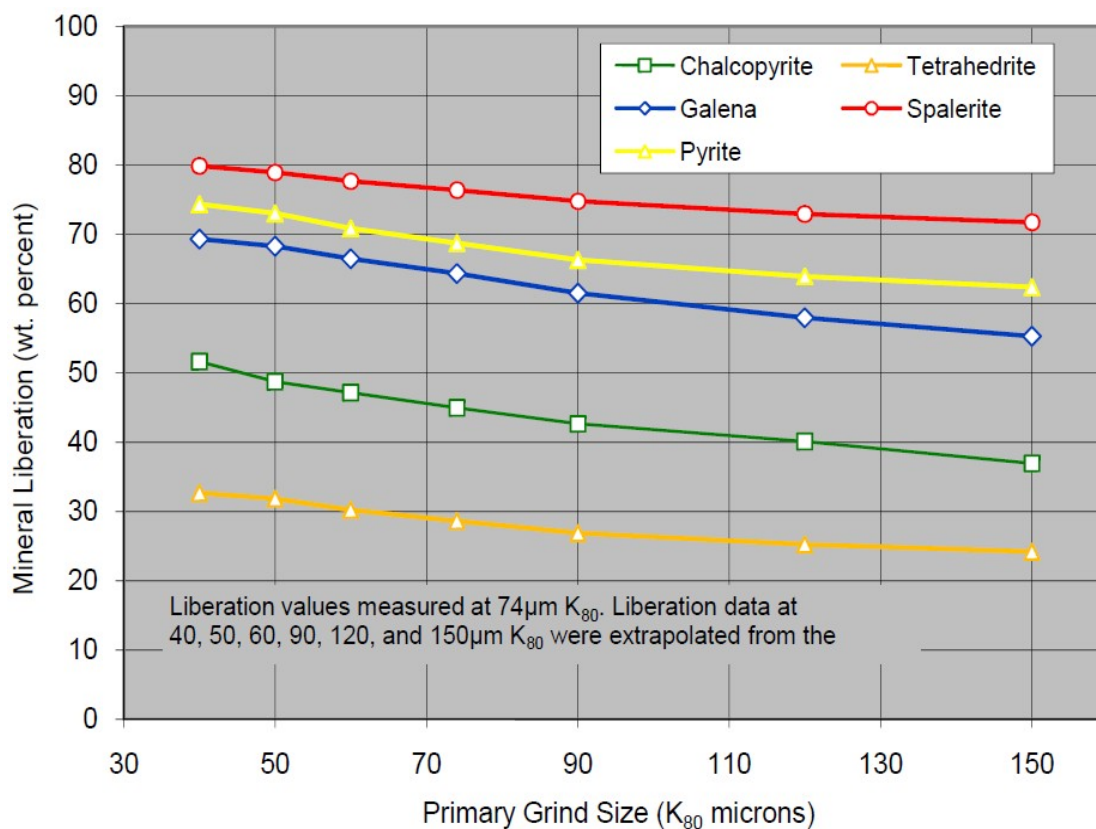
Figure 13.2: Effect of primary grind size on mineral liberation

The primary grind sizing, across the range evaluated, had little effect on the liberation of sulphide minerals. It was therefore concluded that in order to significantly increase mineral liberation values, a major change in grinding sizing would be required.

The fragmentation data can be manipulated to estimate the effect of primary grind size on mineral liberation (Figure 13.2).

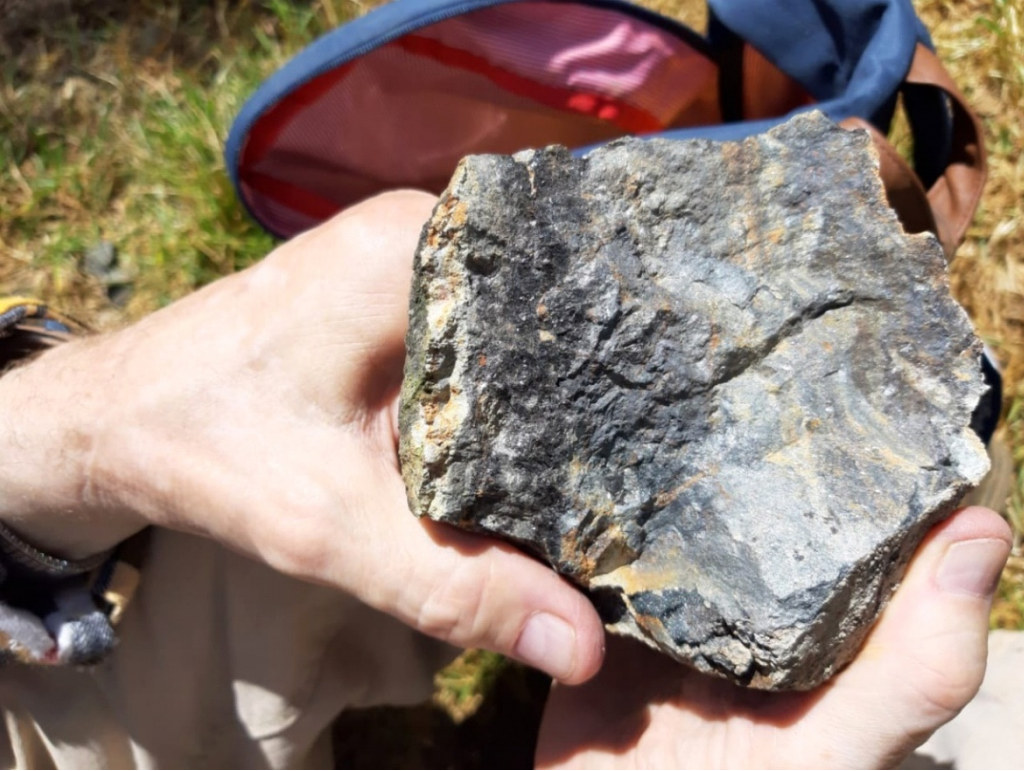
Photo 3: Typical ore sample from San Vicente

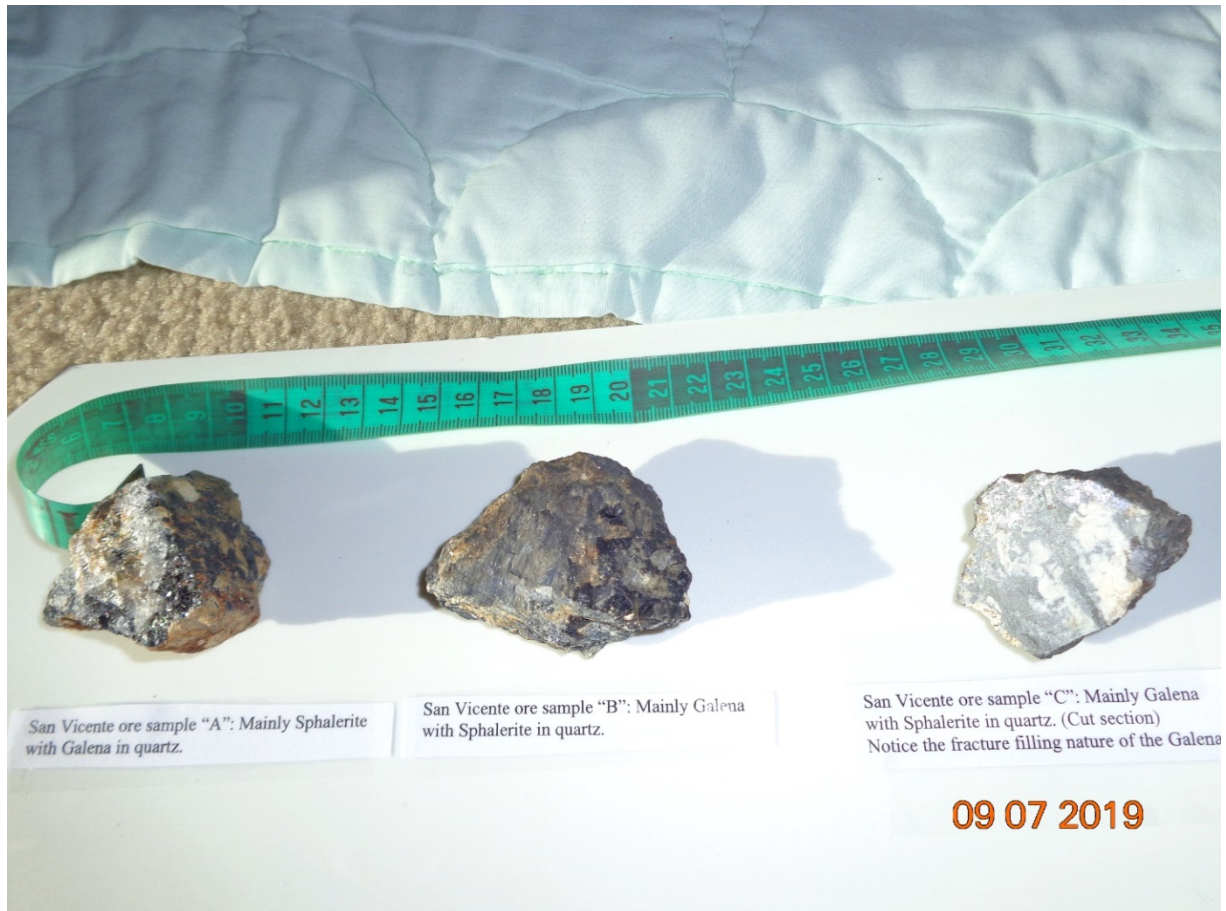
Photo 4: Details of some of the samples collected at San Vicente
